Using an Oscilloscope to Diagnose DTCs

The first time I encountered the P2716 Pressure Control solenoid “D” Circuit DTC on a Toyota Corolla, I didn’t attach much importance to it. It was just one of many possible faults we, as automotive technicians, face every day. However, as I started to see this DTC pop up frequently, I became interested in what the possible causes could be.

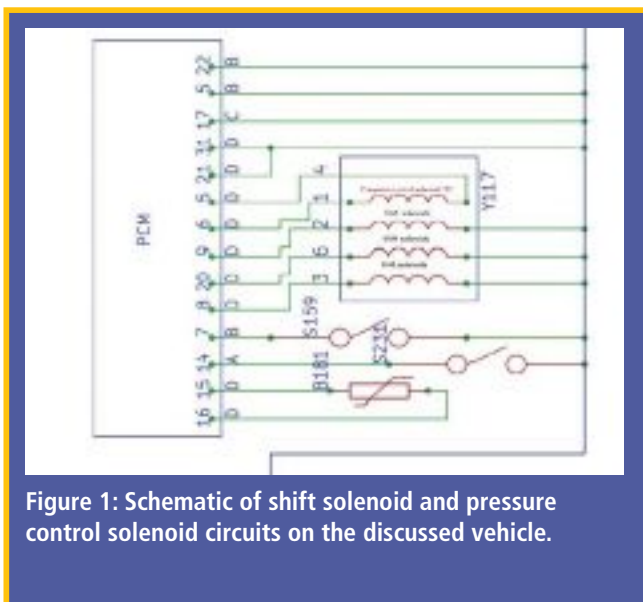
Figure 1: Schematic of shift solenoid and pressure control solenoid circuits on the discussed vehicle.

As can be seen in **Figure 1** on page 18, solenoid “D” is connected to terminals 1 and 4 of the connector. Notice that the PCM supplies both power and ground to the pressure control solenoid through these two

terminals. Contrast this with the shift solenoids that have a fixed ground and the PCM provides a power to operate them. Note that at this point, we do not know which terminal is the power supply and which terminal is the ground or low control for the pressure control solenoid.

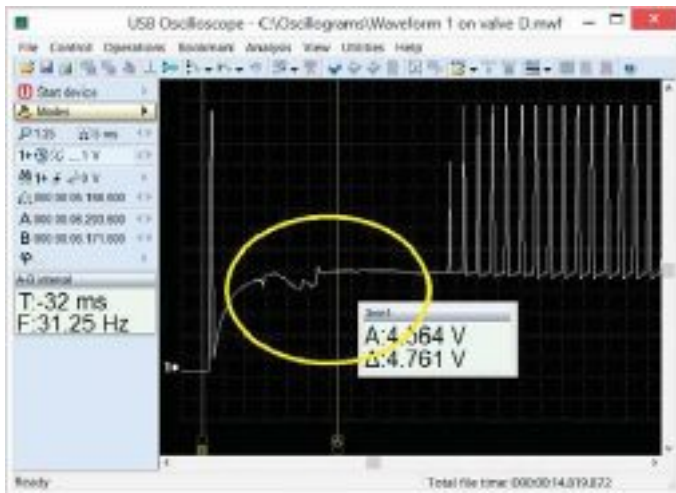
Figure 2: Waveform on terminal 4 of the transmission connector.

The oscilloscope was connected between ground and terminal 4 on the transmission connector. The waveform obtained from terminal 4 can be seen in **Figure 2**. You can see that the voltage on the control or ground side does not drop below 4.5V, and that the control voltage is unstable.

Based on the waveform, it is very likely that pin 4 is the ground-controlled side of the circuit. However, in order to make a final decision, we will need more data. The voltage waveform alone is not sufficient for a good analysis. If we can observe both the voltage and the current waveform from the operating solenoid, we will be better able to make a final determination.

The lack of a complete pull down to ground could be caused by a low resistance path to ground causing current in excess of the capability of the driver in the PCM. The low resistance path could be caused by a shorted solenoid winding or circuit. Also, a poor ground for the control unit circuit could cause the driver to be unable to pull the circuit all the way to the ground potential.

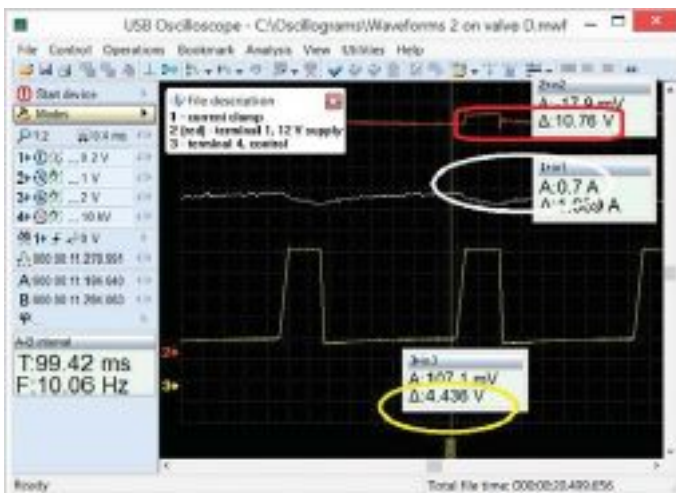
Figure 3: Voltage waveform from both terminals on the pressure control solenoid, along with the current waveform in the circuit.

To gather more data, we used three channels from the oscilloscope as shown in **Figure 3**, waveform #2.

As can be seen in the oscilloscope capture, the supply voltage does not fall below 10.8V, and the solenoid current consumption is normal at approximately 1A. There are no current spikes present in the waveform, which indicates the absence of mechanical seizing or

“stickiness” of solenoid “D”. Based on these observations, there are no external factors that could overload the pressure control solenoid driver. The load is electrically sound, but the driver is unable to provide normal current through the solenoid “D” and is incapable of pulling the circuit below 4.4V.

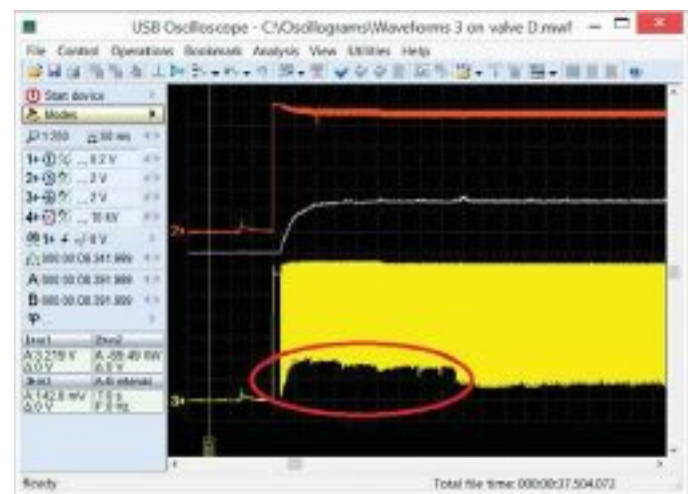
Figure 4: Time compressed waveform from the same capture as in Figure 3.

By using a long time base or time compressing the waveform, the failure becomes clearly visible as shown in Figure 4.

This type of failure could be a defective output transistor driver in the PCM or a poor ground for the driver. In order to determine if it is the driver or the ground, we can check the PCM grounds with an oscilloscope. One way to do this is to connect the four channels of an oscilloscope as follows:

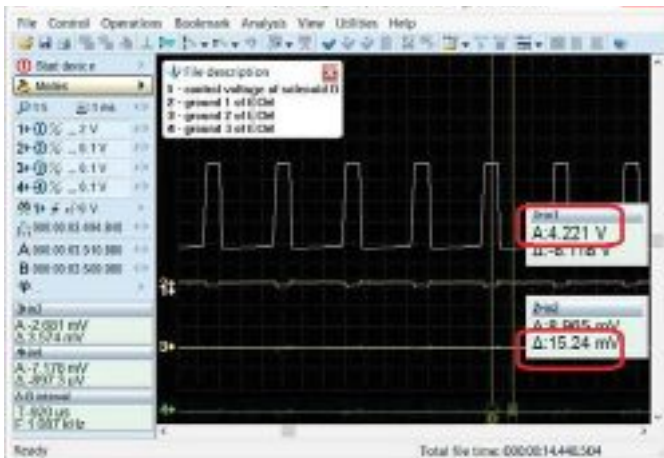
Figure 5: Ground circuit waveforms along with the low or ground circuit for the pressure control solenoid.

On the waveforms in Figure 5, we can see that the solenoid circuit does affect one of the grounds. The affect, however, is infinitesimal at only 15 mV and will have no discernible effect on the operation of the

driver. Based on these measurements we can conclude that the reason for the 2716 DTC is inside the PCM.

In Toyota's TSB (TC015-07), it was confirmed that the PCM in our vehicle, 89661-02S13, is one of the affected control units. The TSB says to replace the PCM. Replacing the PCM does involve considerable expense. It is also a pity to change an otherwise perfectly operational PCM due to one minor defect. The question then becomes: Is it possible to repair the PCM? To answer the question, the control unit was disassembled and the driver that controls the operation of solenoid "D" was located.

Examination of the PCM board revealed a factory defect. The problem was a cold solder joint of two pins of the driver. Since the repair did not involve modifying the circuitry or replacing components, the chip was resoldered.

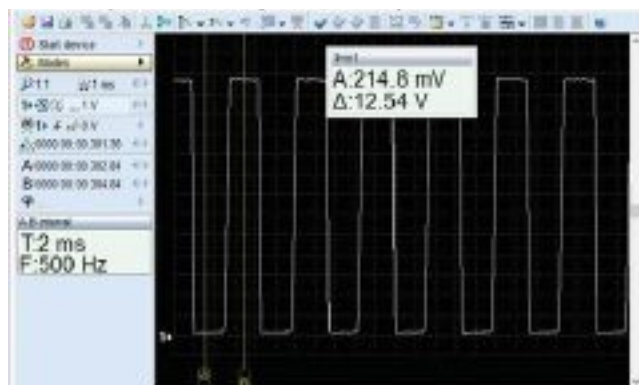
Figure 6: Waveform from pin 4 on the transmission solenoid connector after the repair.

mission solenoid connector. In this capture it can be seen that the solenoid driver is capable of pulling the voltage down to about 214 mV, which is the normal voltage seen from this type of transistor driver.

Considerable testing after the repair verified that the P2716 DTC did not return. The final confirmation test was done using an oscilloscope. The waveform seen in Figure 6 was recorded on terminal 4 of the trans-
