Using an Oscilloscope to Diagnose DTCs

The first time I encountered the P2716 Pressure Control solenoid “D” Circuit DTC on a Toyota Corolla, I didn’t attach much importance to it. It was just one of many possible faults we, as automotive technicians, face every day. However, as I started to see this DTC pop up frequently, I became interested in what the possible causes could be.

**Sergey Vorsin, Vasyl Postolovskyi
and Olle Gladso**

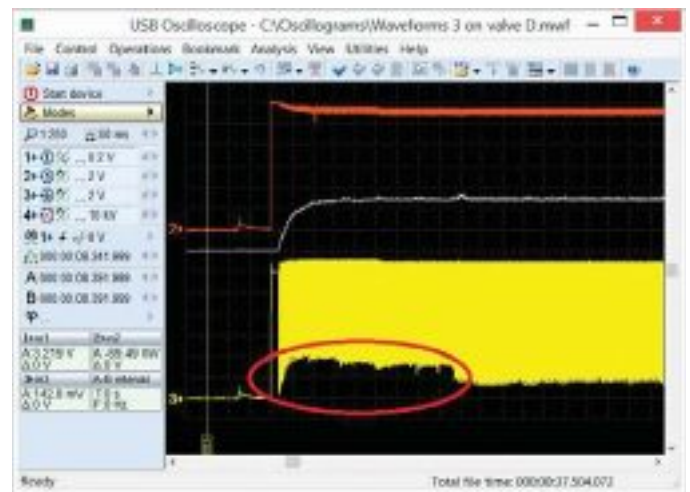
Figure 4: Time compressed waveform from the same capture as in Figure 3.

By using a long time base or time compressing the waveform, the failure becomes clearly visible as shown in Figure 4.

This type of failure could be a defective output transistor driver in the PCM or a poor ground for the driver. In order to determine if it is the driver or the ground, we can check the PCM grounds with an oscilloscope. One way to do this is to connect the four channels of an oscilloscope as follows:
