Diagnosing a Common Rail Diesel Engine

The 2003 Opel Viva-ro, equipped with the 1.9 dCi F9Q engine, is one of the first common rail diesel engines from Renault. This is a simple and reliable engine. The problems we are diagnosing on this particular specimen are: hard cold start, blue smoke from the tailpipe, engine shake or miss, increased fuel consumption and decreased power.

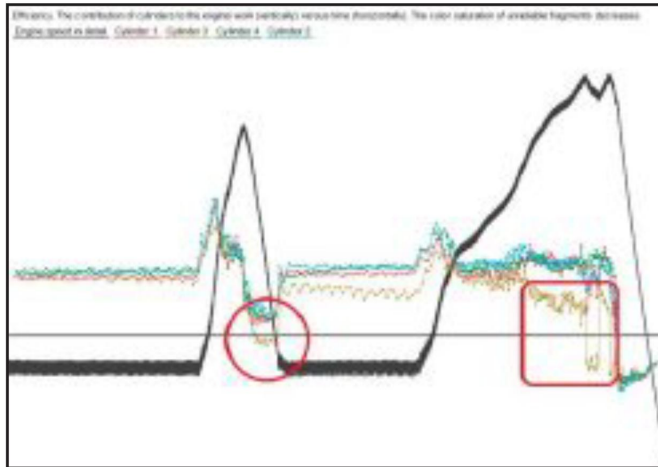
Figure 1: Acceleration and deceleration graph.

During deceleration, cylinder #3 shows a lower dip (marked with a red circle in **Figure 1**). This dip indicates a problem with compression. During partial load conditions, the shake or miss is seen (marked with a red rectangle).

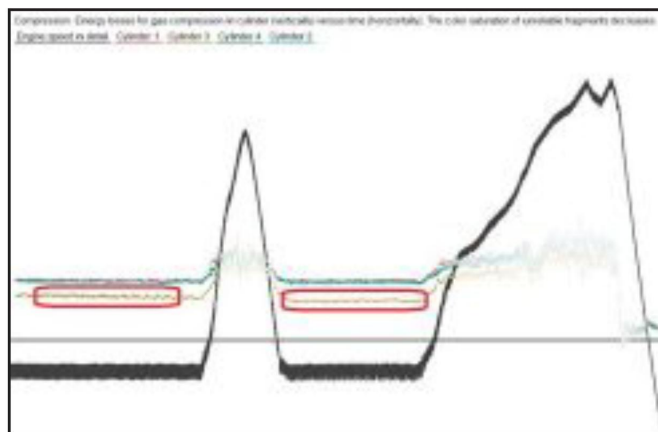
Figure 2: The Compression tab.

Figure 2 shows what the “Compression” tab uncovers.

It can be seen that the resistance created on the compression stroke by cylinder #3 is much smaller than from the other cylinders.

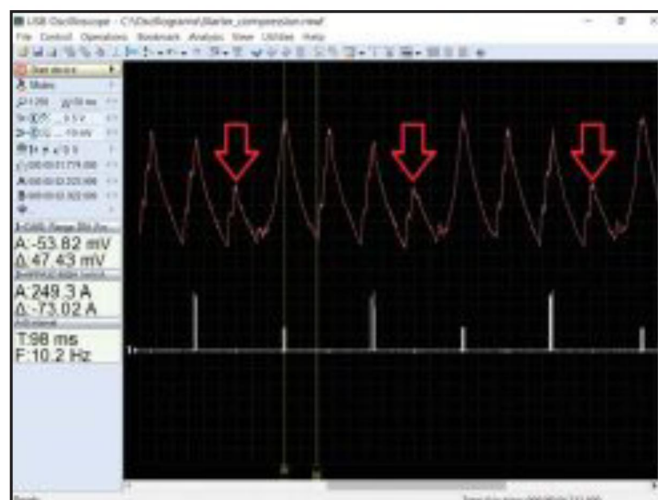
Figure 3: Relative compression.

As verification, the relative compression was checked, as shown in **Figure 3**, by visualizing the starter current as a graph versus cylinder position. To perform the test, the engine must be inhibited from starting.

Cylinder #3 shows a distinct reduction of compression. Using relative compression is a much simpler method than attempting to remove the glow plugs, which may not even be accessible and may break during removal attempts.

At this point, we know that the problem is low compression in cylinder #3. All that is left is to determine exactly why this problem exists. Is it the cylinder/piston or the valvetrain?

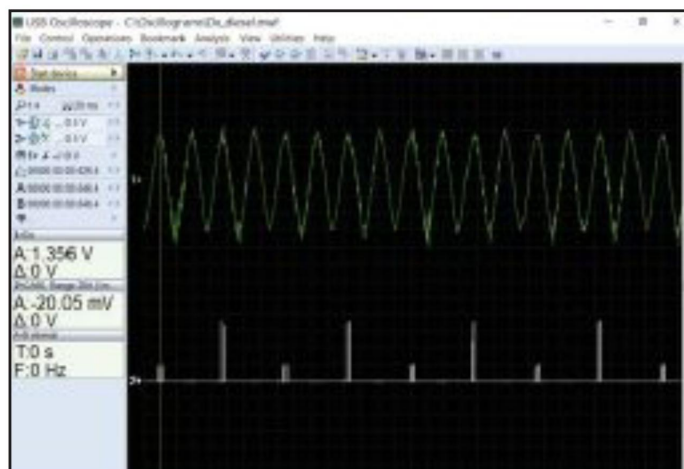
Figure 4:
Crankcase
pressure
waveform.

To determine if the problem is cylinder leakage, a piezo transducer was connected through the use of a suitable adapter to the oil filler neck. As shown in **Figure 4**, this will obtain a waveform of the crankcase pressure pulsations. To synchronize the waveform to the cylinders, a low amp clamp was attached to the wiring for cylinder #1.

The pulsation amplitude variation is minimal. This means that even if there were cylinder leakage, it would be nearly the same for all of the cylinders.

This leaves only two possibilities: a bent piston rod or leaking/misadjusted valves. (It is extremely unlikely that a bad camshaft would cause this amount of compression loss.)

A golden rule is to check the simple things first, so a valve adjustment was performed. The exhaust valve clearance on cylinder #3 was found to be way too small. After proper adjustment, the engine performed as it should. **TS**
