he vehicle in this month's Maximizing Tools is a Nissan that was towed into our shop as a no-

MAXIMIZING TOOLS

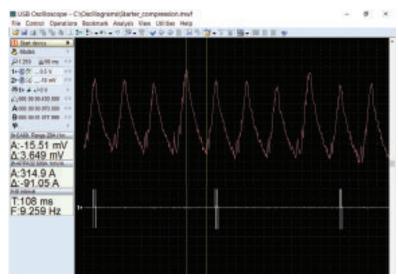
Figure 1: Relative compression test.

According to Figure 1 there is not much wrong with the relative compression. The current increase, or delta, is about 90A when the pistons are coming up on compression. There is a slightly larger delta in cylinder No. 2, but not very significant. The other cylinders are similar to each other. However, why is the engine experiencing a backflow of exhaust gases? Since the glow plugs are easy to access on this engine, I decide to perform an absolute compression pressure test as well. For this test I use a pressure sensor (the PX35).

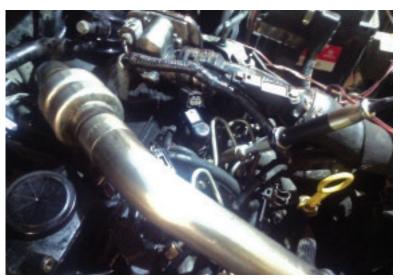
Figure 2: Using a pressure sensor to perform an absolute compression pressure test.

Figure 2 shows the pressure sensor attached in place of a glow plug.

Cylinder No. 1: 21.7 Bar (314.65 psi) Cylinder No. 2: 22.8 Bar (330.6 psi) Cylinder No. 3: 21.8 Bar (316.1 psi) Cylinder No. 4: 21.5 Bar (311.75 psi)

When taking into account the slight pressure loss from using an extension on the transducer, the compression is normal. Cylinder No. 2 has slightly more pressure compared to the others. This confirms the results from the relative compression test.

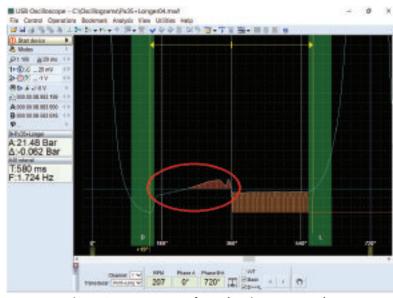
Figure 3: Pressure waveform showing an anomaly.

Figure 3 is the pressure waveform from one of the cylinders and there is an anomaly that warrants further investigation.

The inclined line on the exhaust stroke on a typical diesel engine is normally not seen — the line should be horizontal. The incline suggests a pressure rise in the cylinder on the exhaust stroke.

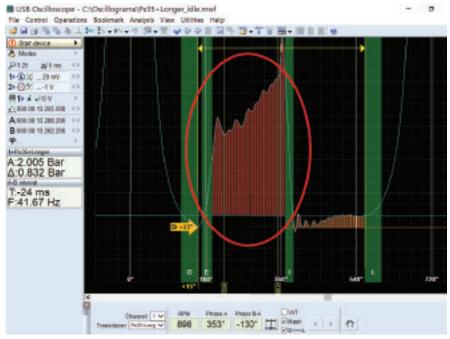
Figure 4: Cylinder pressure waveform at idle.

The waveform clearly shows a significant exhaust backpressure. There is about 2 Bar, or almost 30 psi, backpressure in the cylinder. The cylinders cannot expel the exhaust. The problem is most likely a literally completely blocked exhaust system. The customer had called a while back and complained about an intermittent loss of power, but didn't have time to bring the vehicle in for us to diagnose the problem.
