The vehicle is a 2008 Hyundai Santa Fe equipped with a D 2.2 – TCI – D diesel engine, which has a displacement of 2.2 liters.

**By Olle Gladso and Sergey Gazetin**

# MAXIMIZING TOOLS

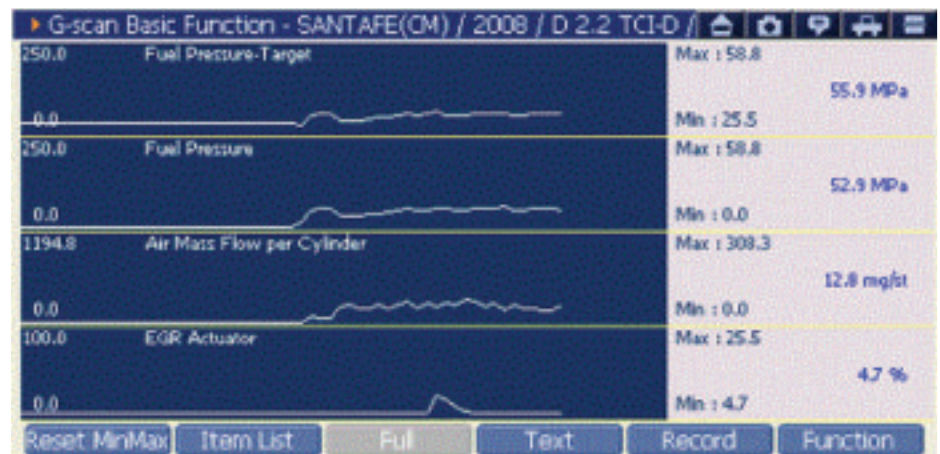
up until the problem is present and observable. The vehicle owner understood and agreed to drive the vehicle with a scan tool connected until the problem would manifest. I connected a G-Scan to the diagnostic connector, activated the graphics mode, as can be seen in **Figure 2**, and the customer drove off. This first trip, even though it lasted well over an hour, had no malfunctions. We gave up, at least for the time being.

Figure 2: Graphical parameters output mode.

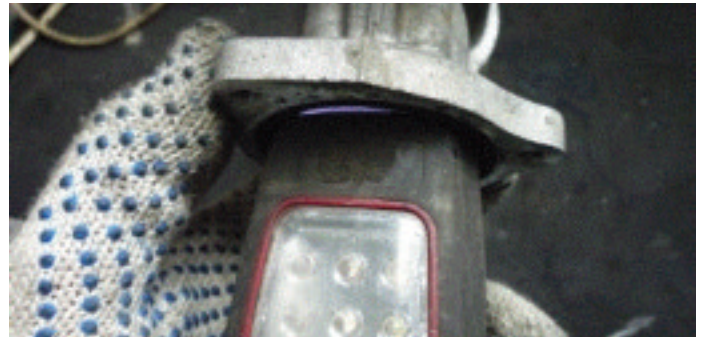
Figure 7: External light source.

**Figure 6, 7 and 8** show the process used to verify that the valve was, in fact, stuck slightly open. The opening is not very evident by just looking at the valve, so an external light source was used. The light shining through the valve as shown in **Figure 8** clearly gives evidence to our suspicion.

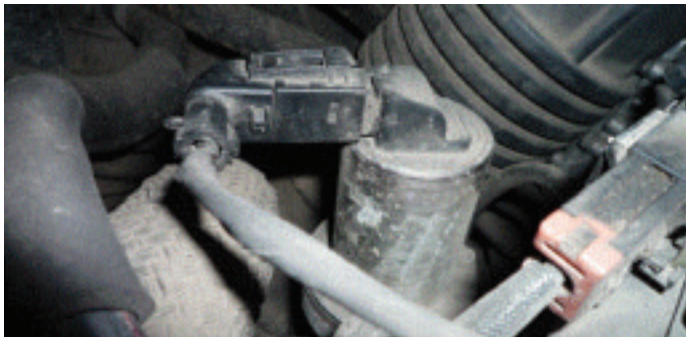
Figure 4: EGR valve.

**Figure 4** shows the EGR valve. **Figure 5** shows the disconnected connector with only two wires going to the valve. Since there are only two wires, there is no valve position sensor. The lack of a sensor explains why there are no trouble codes in the ECU for a stuck open EGR valve. The ECU simply does not know the valve position.

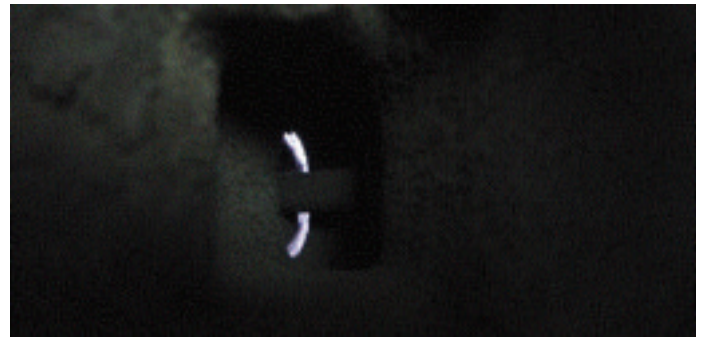
Figure 8: Valve stem slightly open.

It is noted that there are no data related to the valve's position, but the symptoms would certainly indicate a slightly open valve. The vehicle is emitting white exhaust, indicating unburned diesel coming out of the tail pipe.

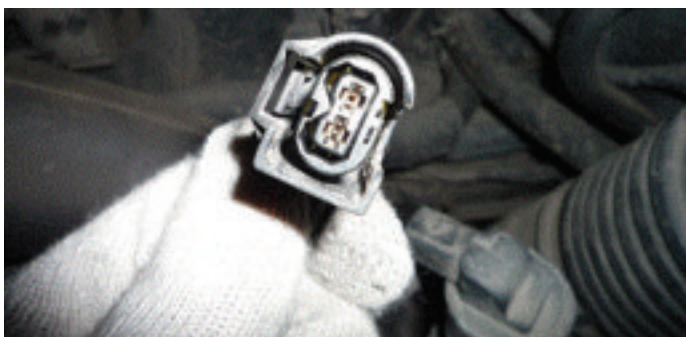
Figure 5: The disconnected connector with only two wires going to the valve.

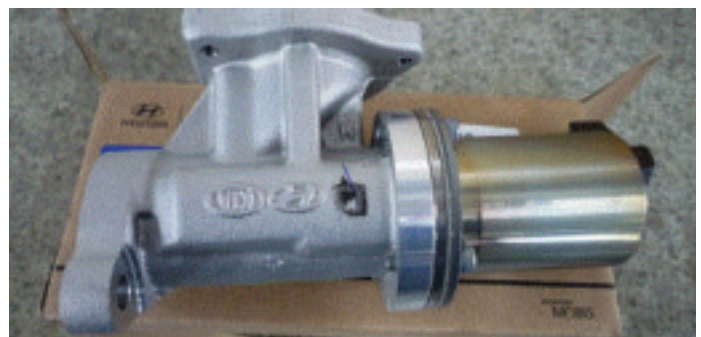
Figure 9: New EGR valve.

The installation of a new valve shown in **Figure 9** solved the problem. **Figure 10** shows the scan tool data taken from the same engine, now with a new valve installed.

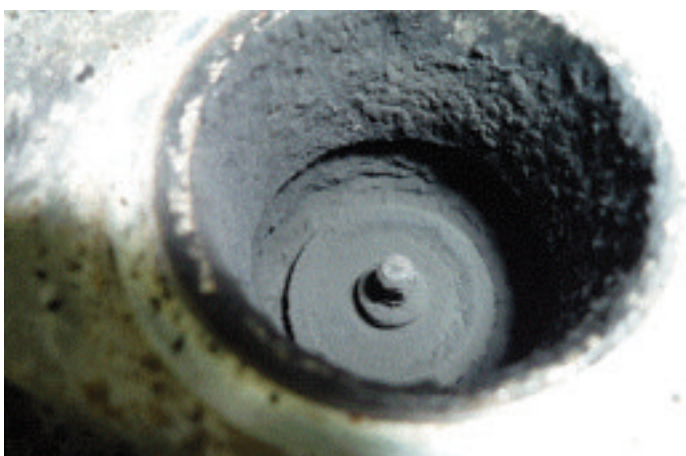
Figure 6: View of the valve from the inside.
