Big Consequences of a Small Problem

2013 VW
Jetta TDI 2.0

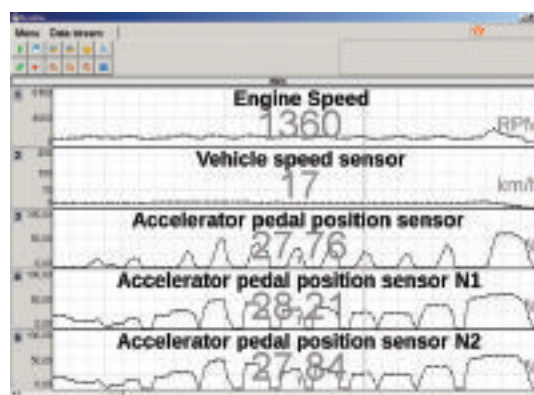
Figure 1 is a screenshot taken while the failure is not present.

- APP sensor N1 is at 28.21%
- APP sensor N2 is at 27.84%
- APP sensor is at 27.76%.

Figure 1:
Normal
APP data.

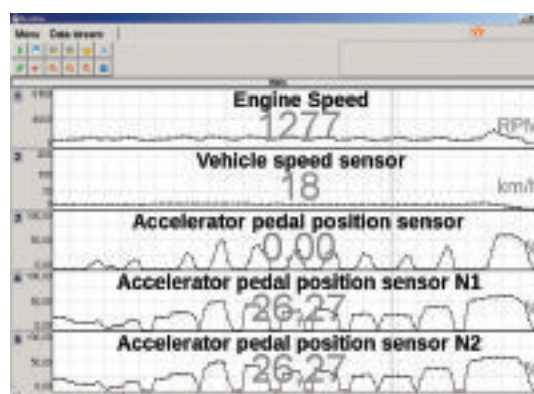
The ECU, however, intermittently calculates the actual pedal position as 0% as seen in **Figure 2**.

At this time it is unclear why after several seconds the ECU will sometimes set the pedal position to 0% and sometimes to the actual value as seen by APP N1 and N2.

Figure 2:
The ECU
intermittently
calculates
APP position
to 0%.

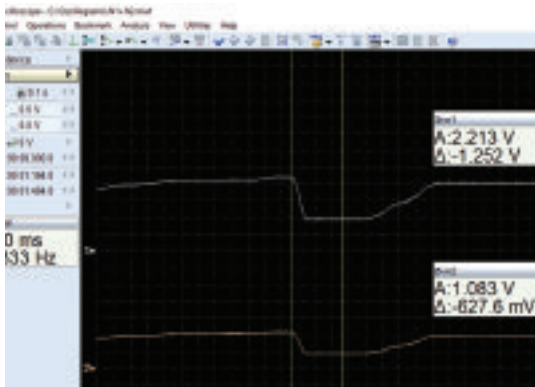
Figure 3:
APP signals
with no
electrical
problem
evident.

The resulting waveform is shown in **Figure 3**. On the waveform it is clearly seen that the signals from the APP sensors N1, N2 have no noise or interference. The voltages have the expected spacing during all operating conditions.

Since the oscilloscope was connected to the ECU connector and the signals were clean, it can be concluded that the sensors and the wiring are OK. That being the case, an internal ECU problem or another external problem must be interfering with the processing of the APP data, causing actual throttle position to be intermittently set to 0%.

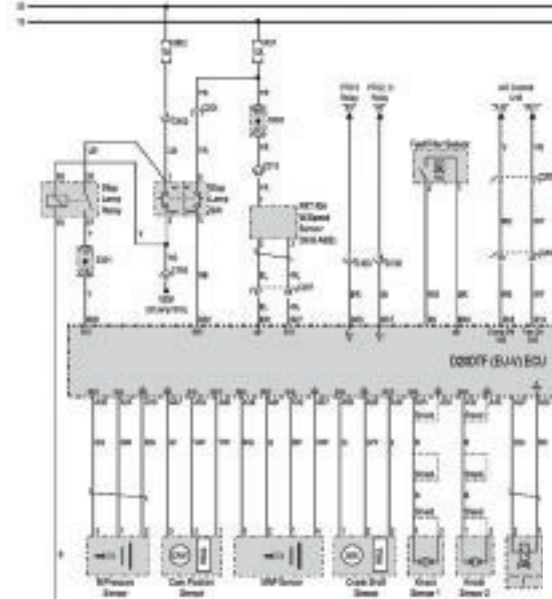
Figure 4:
Wiring
diagram
APP and
brake pedal
sensor.

Studying the wiring diagram in **Figure 4**, it was decided that possibly the stop lamp switch or circuit could affect the throttle operation.

The stop lamp switch was tested and determined to operate as intended. However, when the brake pedal was pressed, the park lamps also illuminated along with the stop lamp. The opposite was also true;

when turning on the park lamps, the stop lamp also illuminated. The reason for the errant behavior was a cross-short circuit inside the combination tail/stop lamp between the two filaments. When the taillights were "on," the ECU would receive a "brakes applied" signal and would assume the signal from the APP N1 and N2 were erroneous since you don't normally depress the accelerator and the brake pedal at the same time. The ECU would then set DTC P0121 and go into a fail-safe mode, limiting throttle valve opening.

No other problems were found and replacing the combination tail/stop bulb resolved the problem. Small problems can sometimes be very difficult to diagnose! **TS**
