# FOURTH TIME'S A CHARM

**T**he saying goes that lightning never strikes twice in the same place. Apparently, this was not the case for a Mitsubishi Eclipse 2.4 2003 4G64 that showed up with a complaint of a rough running condition and a no-start when warm. A DTC scan revealed a DTC P0340 CMP (camshaft position sensor) A Circuit Malfunction Bank 1.

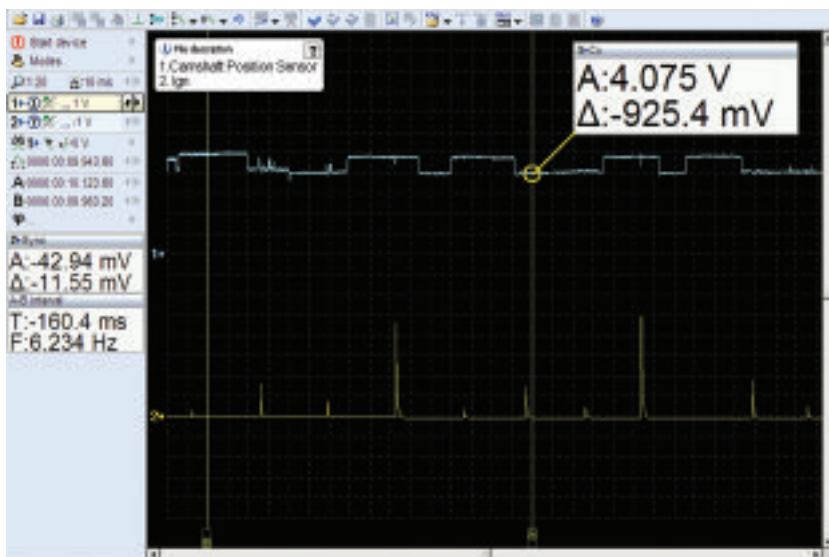
A connected oscilloscope showed the waveform as it appeared in **Figure 1** on page 8 if the engine was warm. As can be seen, the output voltage at the points when the signal is designed to be close to zero volts was far from at ground level. As the working temperature of the engine increased, the low point of the waveform became 4 volts. The PCM did not recognize this as a valid signal and did not open the injectors. This type of failure is quite common.

Figure 1: Signal not being pulled to ground.

Without any further testing a new CMP was installed.

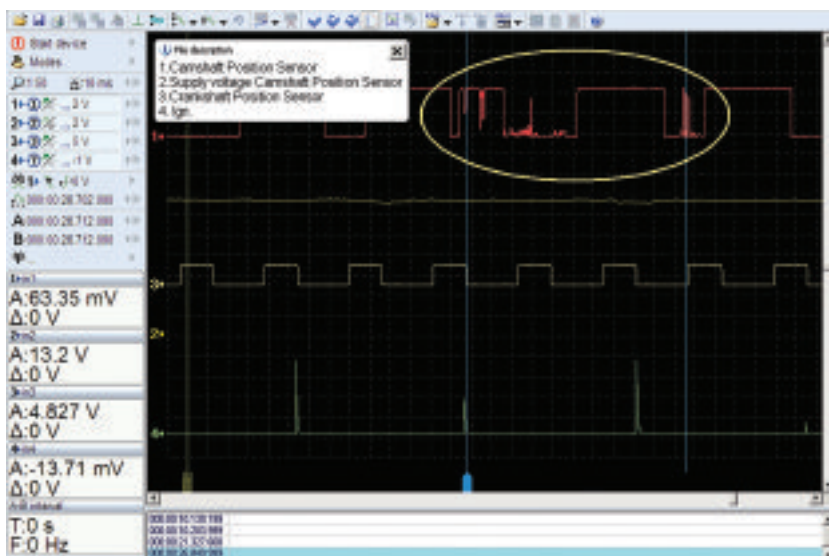
Figure 2: Interference to the signal from the sensor.

The oscilloscope was again connected to the signal wire from the sensor. The result is seen in the waveform shown in **Figure 2**. There is a clear interference to the signal from the CMP. This particular problem is most likely caused by a bad sensor low reference (ground or a defective sensor). The wiring was checked and verified to be in good condition. So, the sensor was replaced again.

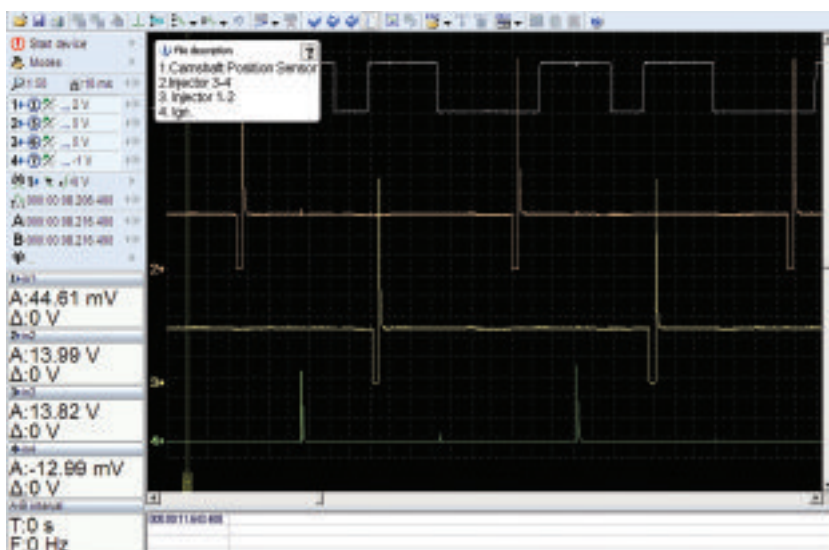
Figure 3: Sensor 3 at idle.

In order to fully, and hopefully for once, understand and repair the problem, the oscilloscope was again pressed into service — this time in a four-channel mode. Channel one was connected to the CMP, channel two to injectors 3-4, channel three to injectors 1-2 and finally, channel four was connected to ignition. **Figure 3** shows the waveforms when the engine is running at idle and with no apparent failure present.

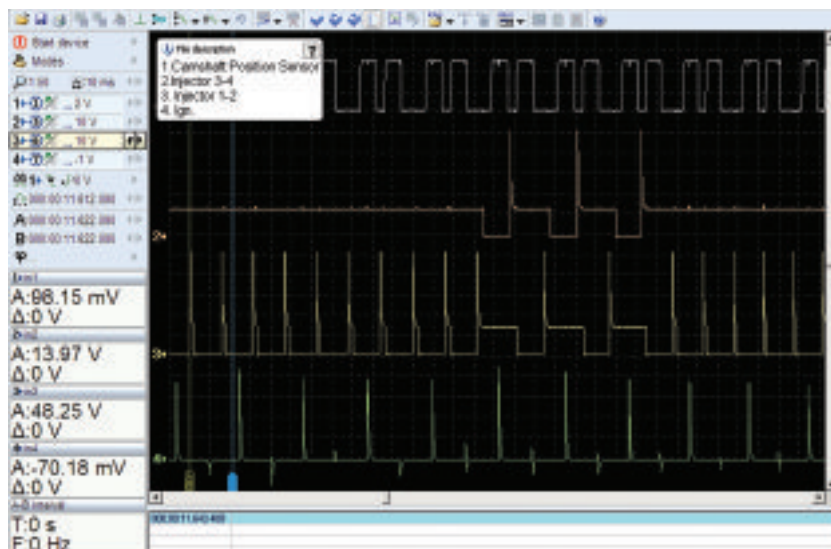
**Figure 4** shows what happens when the throttle is opened so the engine is no longer at idle speed. Injectors 3-4 will only occasionally operate, most of the time they are non-functioning. Injectors 1-2 on the other hand, are open most of the time and only occasionally closed.

They are feeding a large amount of fuel into cylinders 1 and 2. At first glance, the CMP signal, oddly enough, appears nominal, with no discernible problems shown in the waveform. The ignition waveform does not show any apparent failures either.

Figure 4: Waveforms with engine off idle.

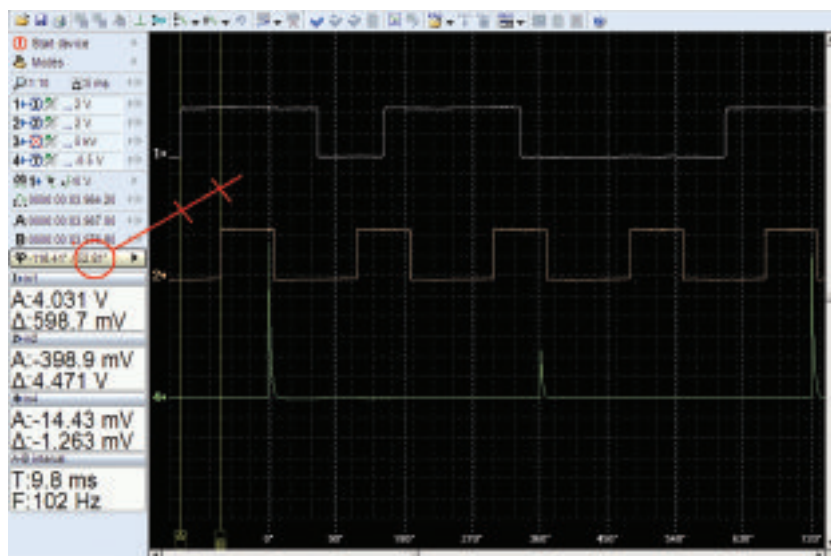
**Figure 5** shows our reference waveform. It contains the CMP on channel one, the CKP on channel two and ignition on channel three. Using these waveforms we can determine that the rising edge of the signal from the CMP occurs approximately 53 degrees before the rising edge of the signal from the CKP.

Figure 5: Reference waveforms, known-good sensor.

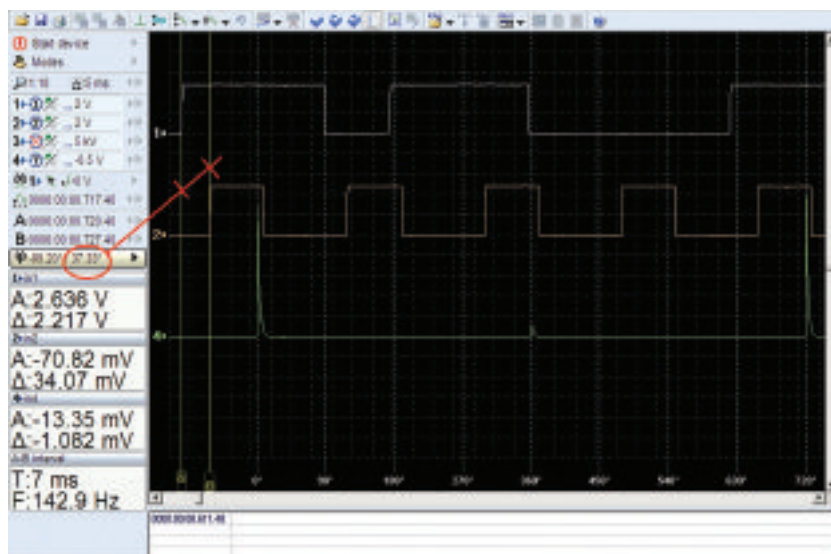
The same connections and settings were used to record and analyze the signals from the third CMP sensor, which was failing once the RPM went above idle speed. The result is shown in **Figure 6**. On this capture it can be seen that the rising edge of the CMP signal occurs 37 degrees before the rising edge of the CKP signal. Thus, the delay is 3ms. At idle the 3ms delay is not large enough to affect engine operation, but at higher RPM, 3ms becomes significant and affects engine operation.

Figure 6: Signal from the failing sensor 3.

In this case, the fourth time was a charm and the next replacement of the CMP sensor finally fixed the car.
