**T**he CKP (Crankshaft Position Sensor) is one of the basic diesel engine sensors and is necessary for an electronically controlled diesel engine to even start. Let's have a look at some CKP failures that we have seen.

## Ford Transit 2014 2.2 HDi Puma C

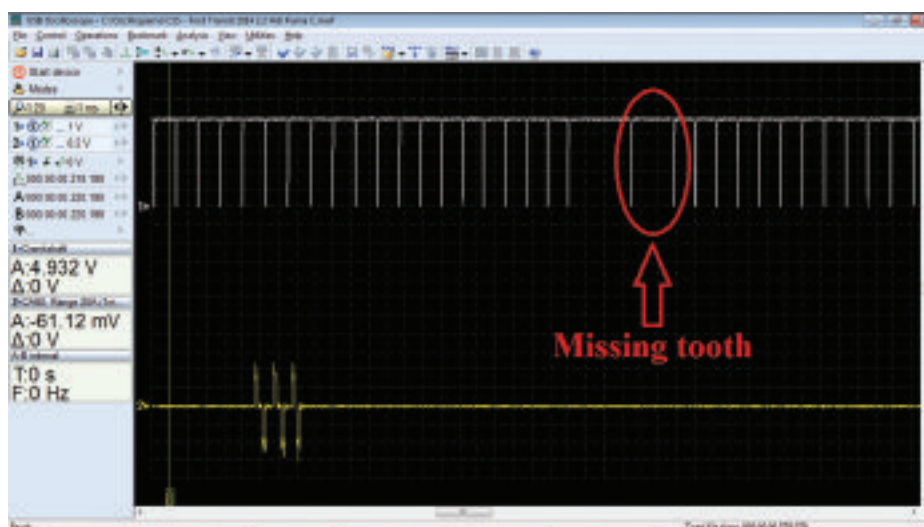
Figure 1: Once the signal from one of the teeth disappears, the engine stalls because the PCM shuts off the injectors.

After just a little while, the engine stalled. Upon careful review of the recording, the following is seen in **Figures 1 and 2**. One of the markers or teeth is suddenly missing, apparently causing the stall.

The cause of this behavior was an incorrectly installed CKP sensor. Once the air gap was adjusted correctly (adjustable on this particular engine), the problem disappeared. Oddly enough, the engine always started and ran well, the problem would only manifest itself at idle. The PCM did not immediately flag the error either, the engine had to run for a little while.

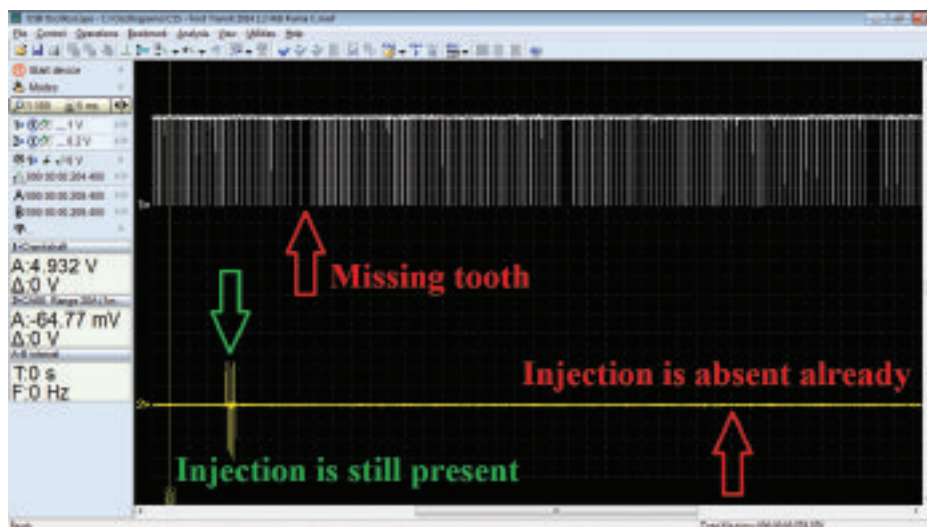
Figure 2: Missing tooth signal causing the injectors to be shut off.

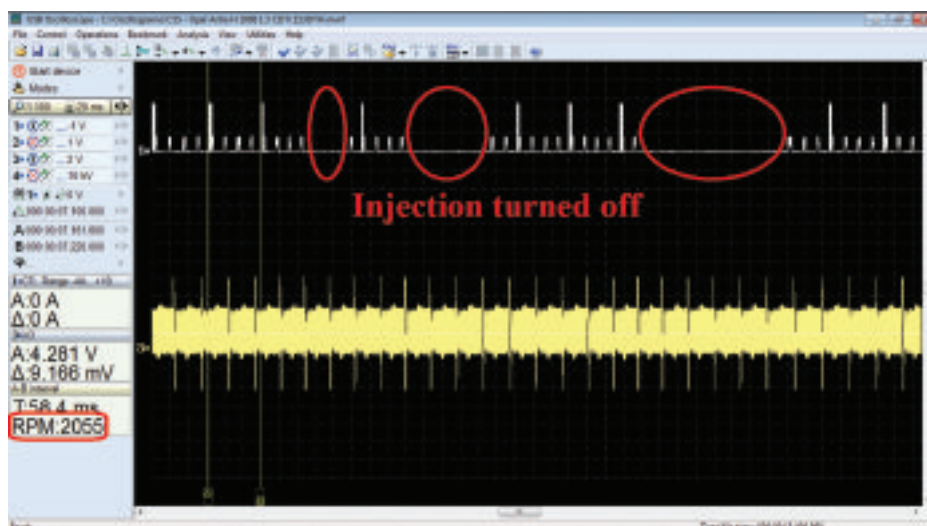
Figure 3: It can be seen that engine speed is above 2000 RPMs, and injection is periodically turned off, which apparently is causing the RPM limitation.

This vehicle came in with the following problem: the engine does not reach target or desired RPM. The problem can occur at different RPMs, such as 1500 or 3000. There are no DTCs, fuel pressure is nominal, it starts well and there is no smoke. No mechanical problems can be found during extensive checking either. In order to do some integrity testing on the electrical and electronic circuits, a USB Autoscope was connected to the CKP sensor and a current transducer was clamped on the first injector wiring. As can be seen in **Figure 3**, the problem showed up almost immediately. **Figure 4** shows the CKP waveform zoomed in closer and the problem is evident.

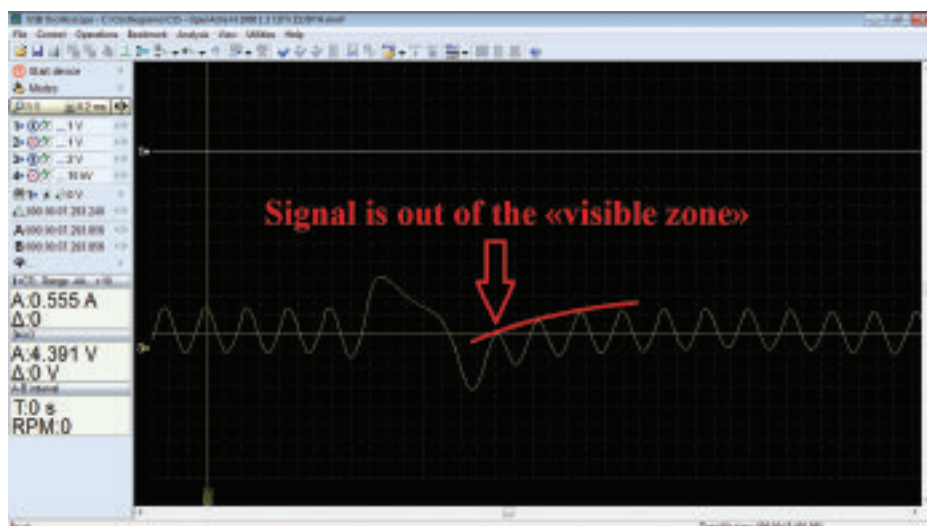
Figure 4: The signal is highly distorted and periodically the ECU (Engine Control Unit) does not see this tooth, shutdown occurs and injection is turned off. The RPM decreases slightly, the signal recovers, the ECU "sees" the signal again and operation is restored. The RPM increases again, and the problem repeats itself over and over again. The reason for the problem was simple: There was a corroded CKP connector. After removing the corrosion and using some stabilizer, the defect did not appear again.

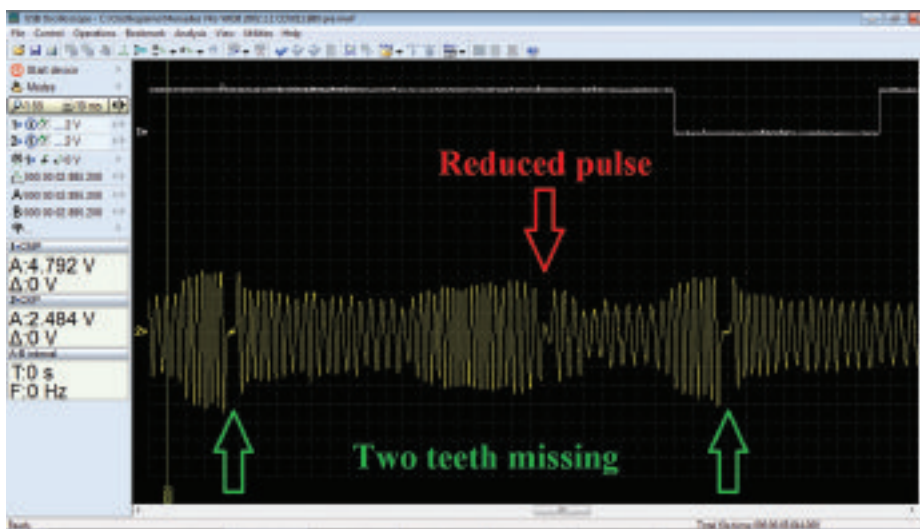
Figure 5: The CKP signal appears to show missing teeth.

The oscilloscope is connected with one channel to the CKP and one channel to the CMP. The waveform seen in **Figure 5** is obtained. **Figure 6** shows that what looks like missing teeth are actually the signal with significantly reduced amplitude.

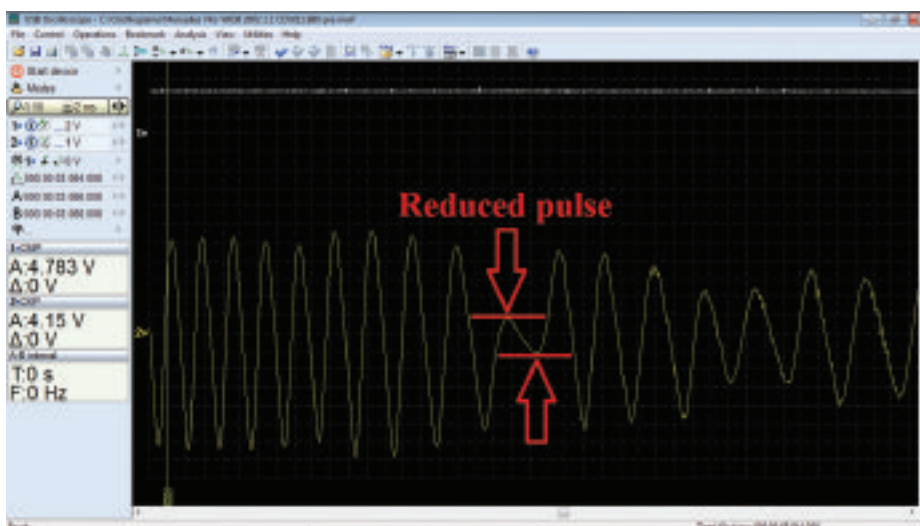
Figure 6: Signal with significantly reduced amplitude.

The ECU interprets the low amplitude signal as a tooth pass, and turns off the injection. The cause was a bent tooth on the toothed disk or reluctor. The technician fixed the bent tooth without removing the transmission. Finally, the car starts. However, **Figure 7** shows that the technician was overzealous, slightly overdid it and bent the tooth too far the other way. **TS**

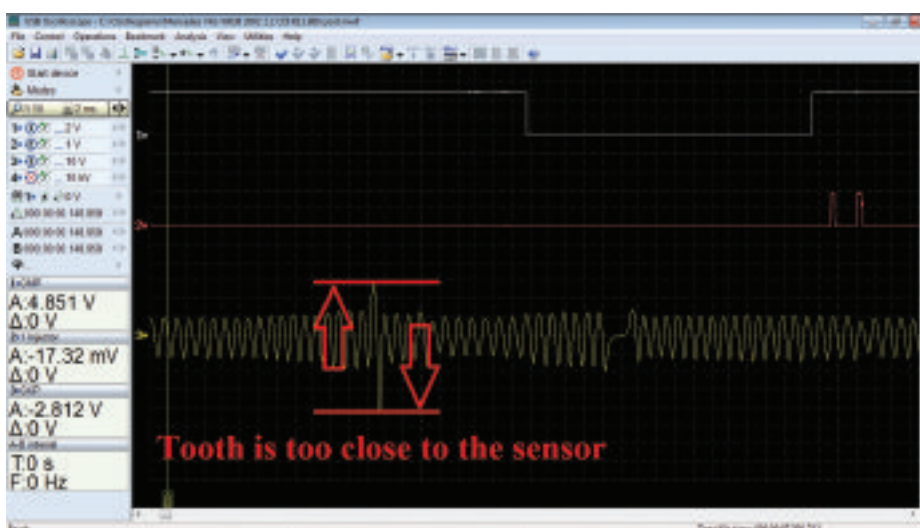
Figure 7: The tooth now is too close to the sensor. So, it had to be "fixed" again.
