# Rough Running Diagnosis

Difficult repair-ability did not stop the owner of a Toyota Caldina equipped with this engine from having serious engine repair done. Three months after the repair (done elsewhere), the owner contacted us with a complaint of roughness and power loss.

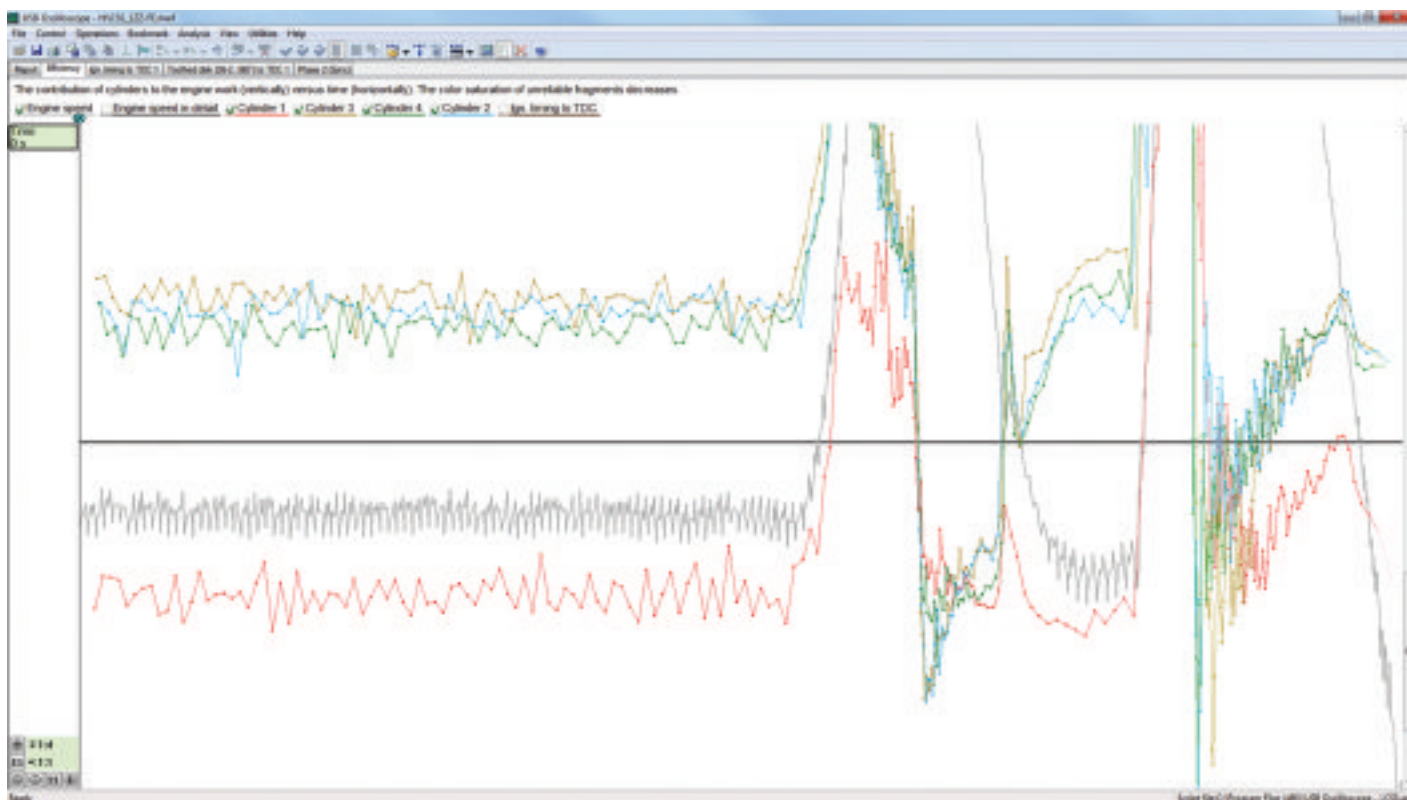
Figure 2: Efficiency graph.

the software and obtain the efficiency graphs of the cylinders of our engine. In **Figure 2** on page 8, the red graph is a graph of the efficiency of cylinder No. 1.

The problem is indeed present, and it is a serious one. The graph clearly indicates a mechanical problem. At idle, cylinder No. 1 did not contribute any power, and only during throttle application did the cylinder show any efficiency at all, its efficiency rose above zero, but was much lower than in the other cylinders.

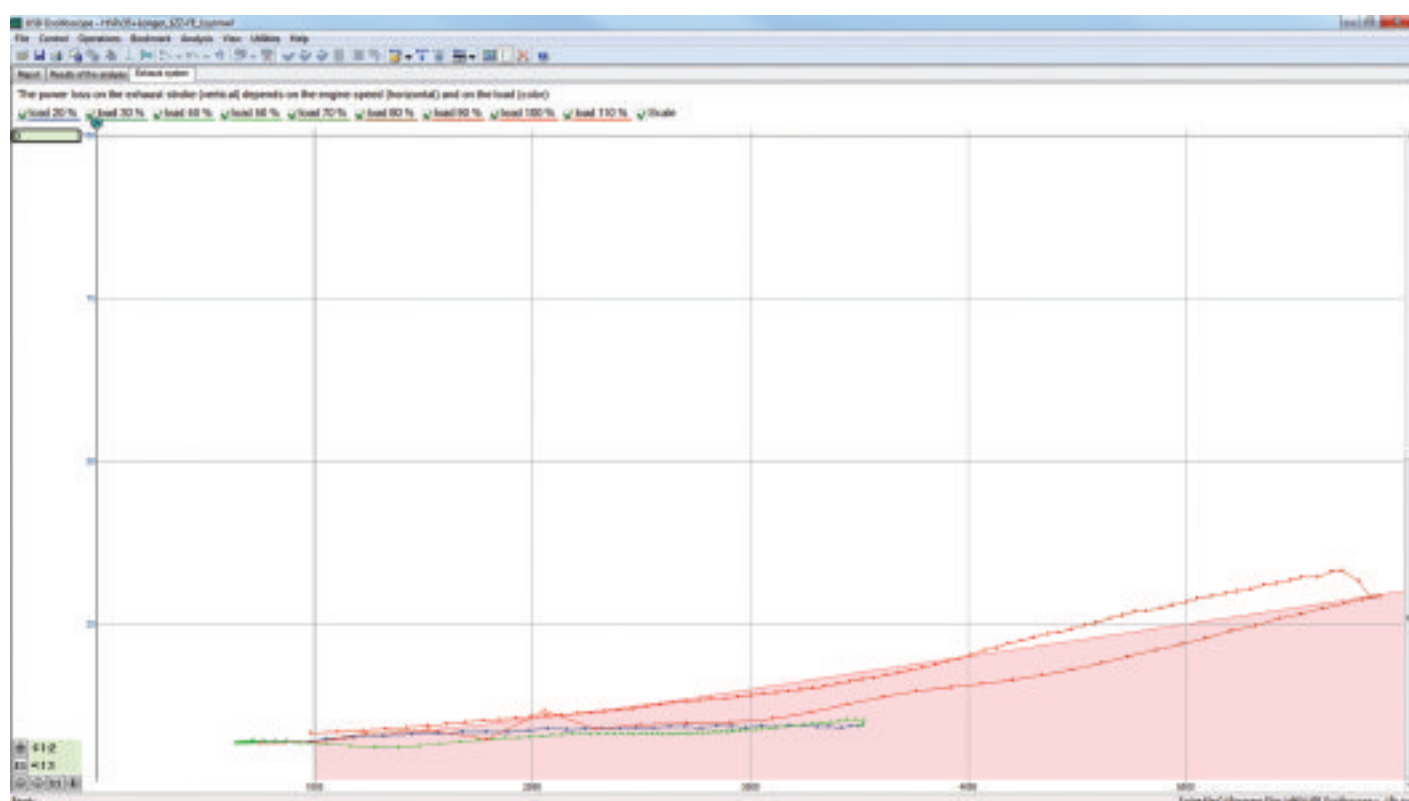
Figure 4: Increased resistance to flow in the exhaust system

Cylinder leakage at 710 RPM was 42%. This is a very large value, the loss of about 15% is considered the norm, and the maximum allowable is up to 20%. Also, on the tab "Exhaust system" increased resistance to flow in the exhaust system is noted, as shown on **Figure 4** on page 12.

The graph shows that there is a blockage in the exhaust system, but only partial. The reason for this diagnosis is that the graph of the power losses during the exhaust stroke only slightly exceeds the allowable limit.

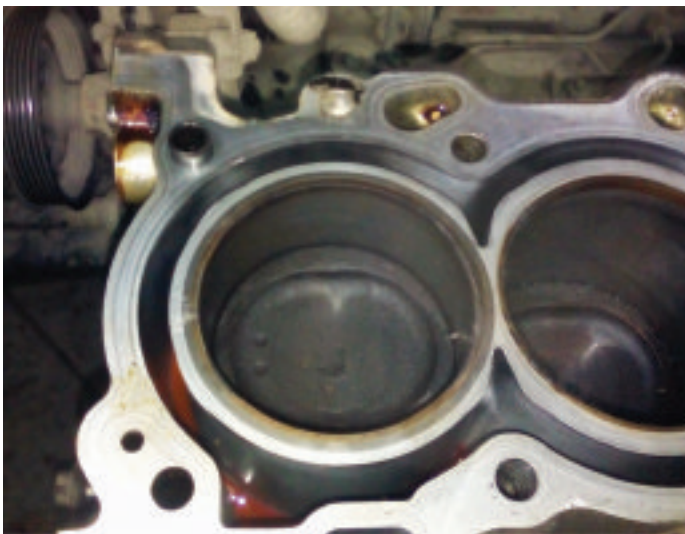
As can be seen in **Figure 6** on page 14, a liner (or sleeve) had been installed in the bore for cylinder No. 1. Apparently, this cylinder was heavily damaged at some point.

The sleeve installation was done correctly and it is an acceptable repair. In fact, the sleeve is often made from more durable material than the block itself and the repaired cylinder should last as long as or longer than the other cylinders.

Figure 6: Cylinder has been sleeved.

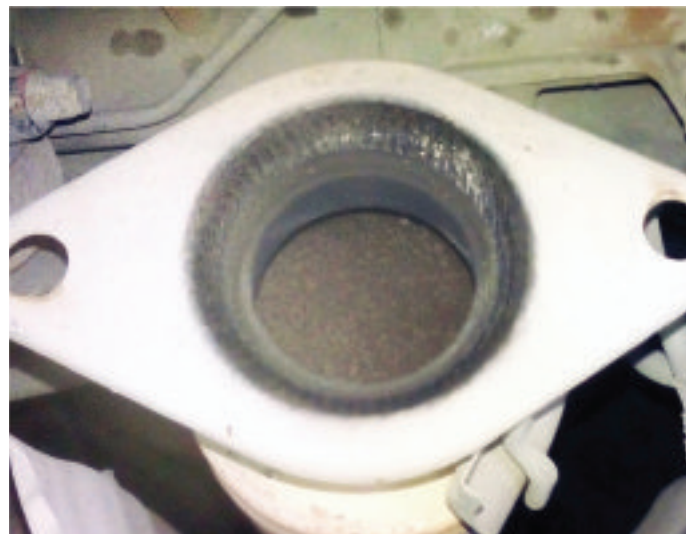
Figure 7: Inside view of catalytic converter.

Figure 7 shows the inside of the catalytic converter, which became accessible as we disassembled the engine.

The view in Figure 7 explains the increased exhaust system restriction found by the software. The converter is not completely clogged, but the openings are obstructed from combustion byproducts and engine wear material.
