# ENGINE DENTISTRY

**By Alexey Pakhomov, Vasyl Postolovskyi & Olle Gladso**

The vehicle is equipped with the 2.5L EJ25 engine. A key feature of this engine is that it is of a horizontally opposite design; the cylinder block is located horizontally, and the axis of the cylinder pairs are opposing each other. This design is known as a boxer engine, because the pistons face opposite each other much like boxer fists.

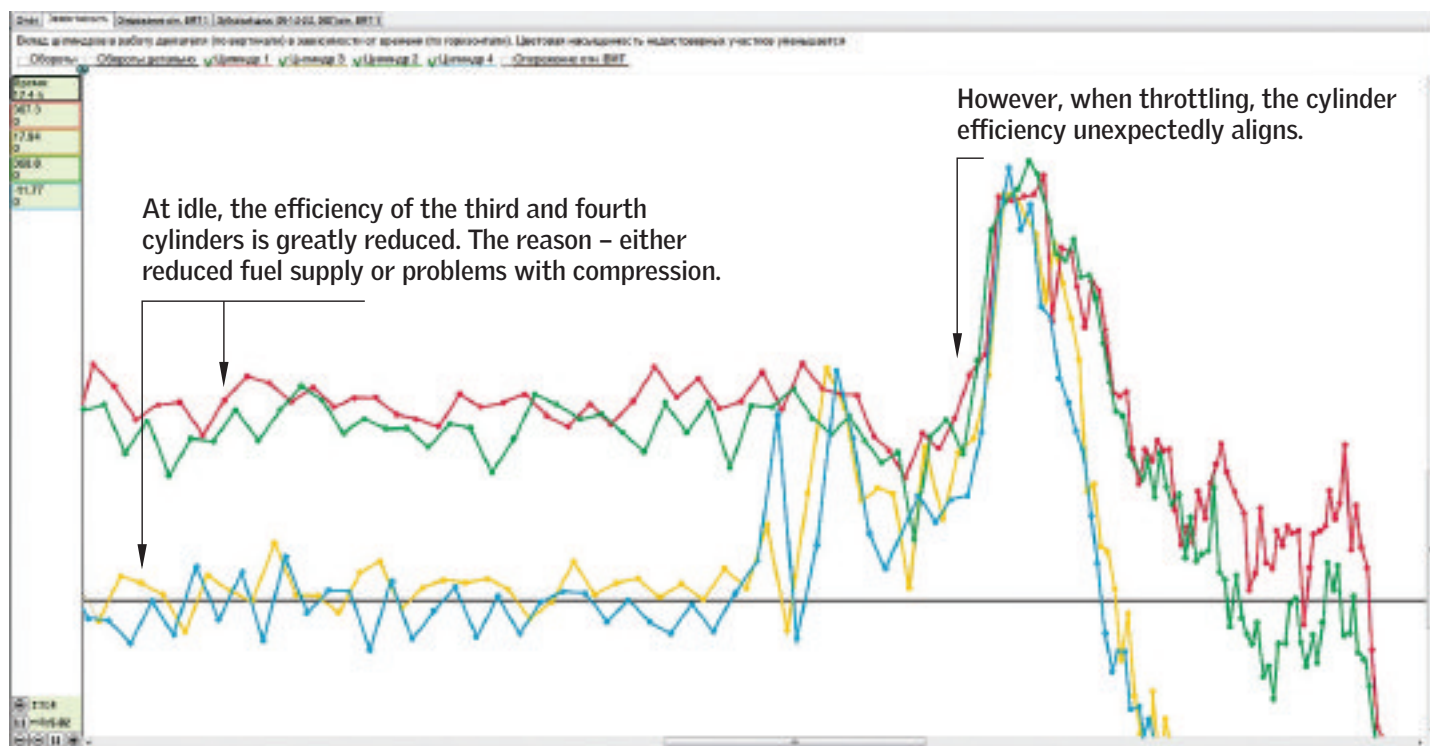
Figure 1: Cylinder power balance test graphs from the subject vehicle.

Unfortunately, there are a number of ambiguities on the graphs.

**Uncertainty No. 1:** During idle operation, two cylinders fell out of operation: the third and fourth. Given the numbering of the Subaru cylinders, this is a pair of cylinders that are opposite each other. If they just fell out, the diagnosis would be fairly straightforward. Unfortunately they behave in a very stable manner, almost as if the behavior is intended to work stably, but on every other combustion event.

**Uncertainty No. 2:** During snap throttle, the cylinder efficiencies suddenly align and become very similar. The problem present at idle suddenly appears to go away.

**Uncertainty No. 3:** The end of the graph, the tail. Here there is

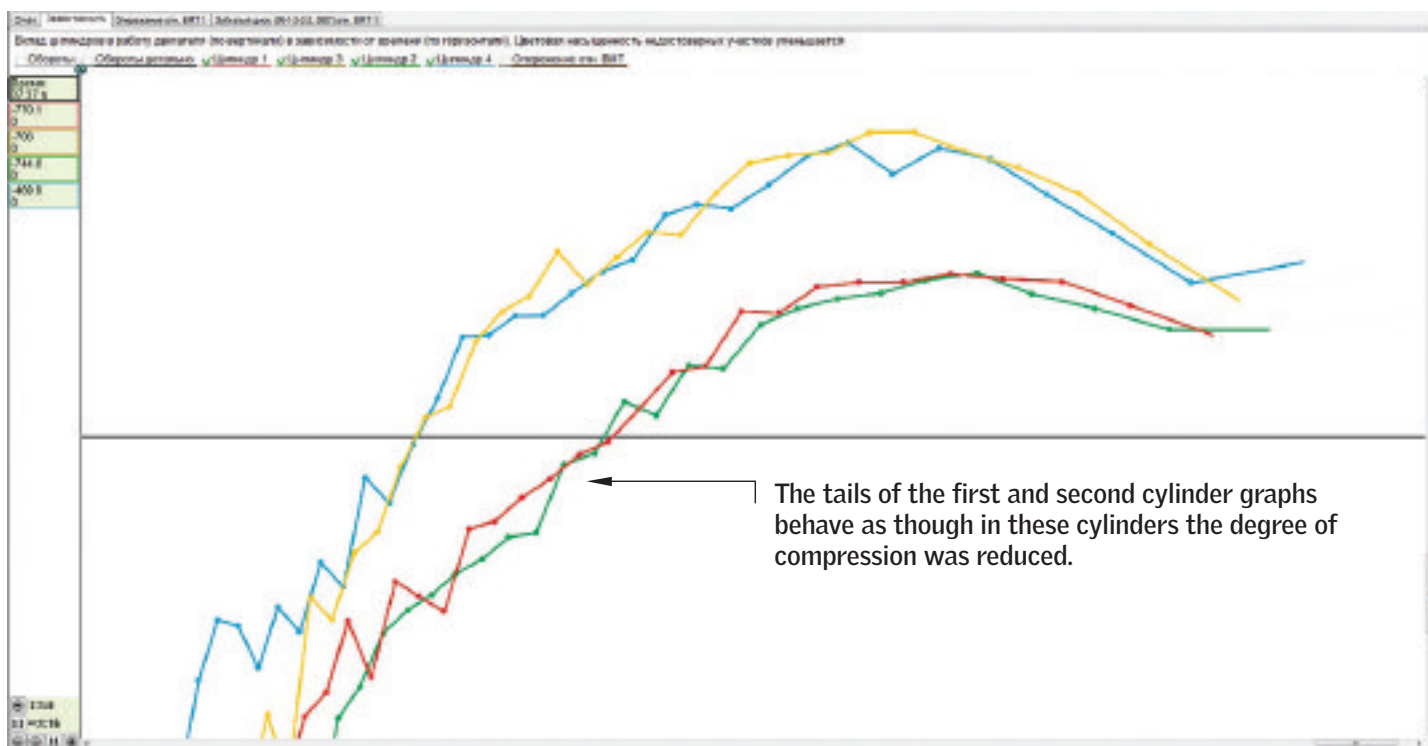
Figure 2: The relative compression part of the graph.

no combustion, so we are measuring cylinder pressure or density specifically. As **Figure 2** shows, the third and fourth cylinders, which do not work at idle, have significantly higher cylinder pressure or compression than the first and second cylinders.

The real strange thing is that the graphs do not show a loss of compression like you would see with cylinder leakage, but rather a lowered compression ratio. Almost like someone installed shorter connecting rods in cylinders No. 1 and 2!

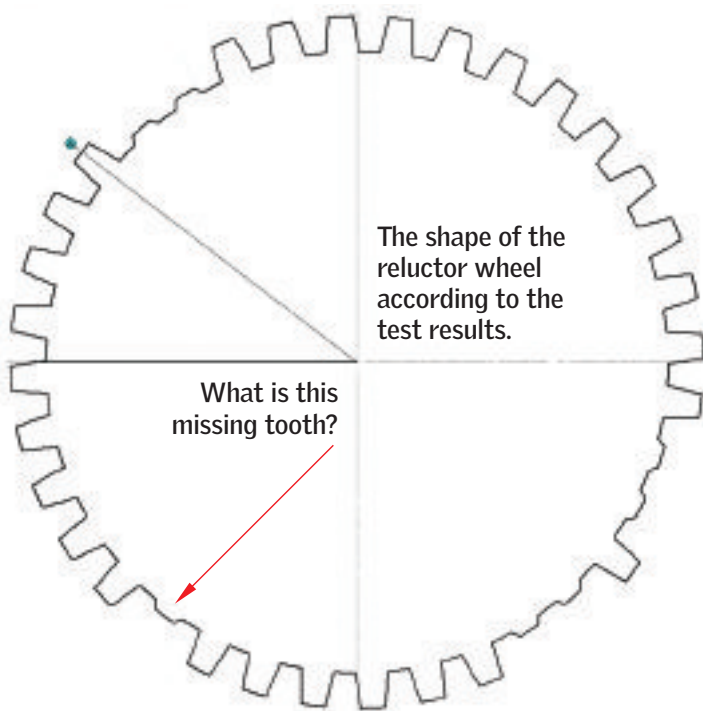
Figure 4: Reluctor wheel test.

Boom! That is worth checking! The reluctor wheel that is. The efficiency test, which we performed at the very beginning, not only builds efficiency graphs, but also measures the parameters of the reluctor wheel at the same time. **Figure 4** shows the result from the reluctor wheel test.

Subaru engines traditionally use a 36-2-2-2 disc. 36-2-2-2 means that the teeth on the wheel are spaced for 36 teeth. However, the design has three pairs (2-2-2) of them missing. That is clearly shown in the graph in **Figure 4**. However, the graph also shows one more missing tooth. The visual confirmation, as shown in **Figure 5**, clearly shows a broken tooth on the reluctor wheel.

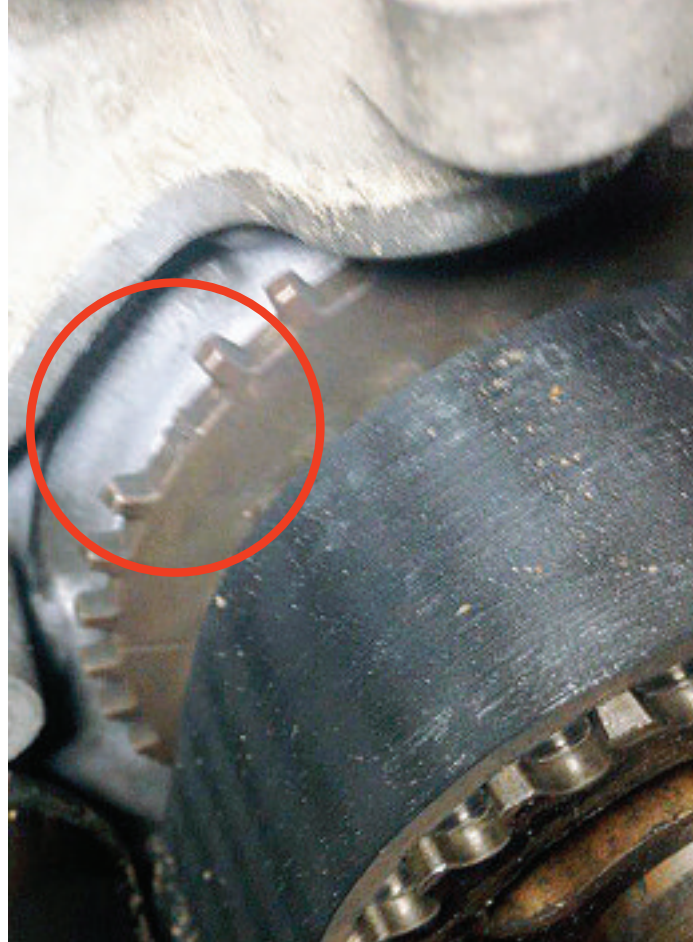
So, the problem was directly caused by the engine overhaul being improperly done. Somebody probably tried to stop the engine from turning using a screwdriver or pry bar on the reluctor wheel. Maybe while aligning the timing belt. Who knows? In any case, don't do it. Way too many reluctor wheels (and flexplates for that matter) have been bent or otherwise damaged doing that. Find a better way.

Figure 5: Shows one tooth of the reluctor wheel is broken.

So, we ordered a new reluctor wheel. It only took two weeks for the new wheel to arrive, but once we installed it, the engine started and ran perfectly.
