## Simple Answers to Difficult Questions: Troubleshooting Complex Systems

### BMW 525

## Audi A6

## Lexus RX 300

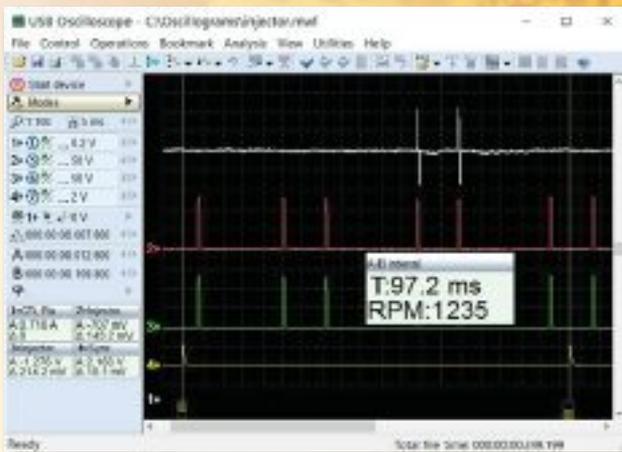
Figure 1: Injector waveforms on problem vehicle.

In order to understand why the injectors are injecting more gasoline, to find out if the reason is internal to the injectors or caused by an external signal, the electrical injector pulse width was measured. The injection was performed at the end of the intake stroke two times with a duration of ~0.5 ms. **Figure 1** shows the injection control signals represented as voltage and current. **Figure 2** is a zoomed-in waveform of the injection control signals. The waveforms do not show any problems with the injector drive system.

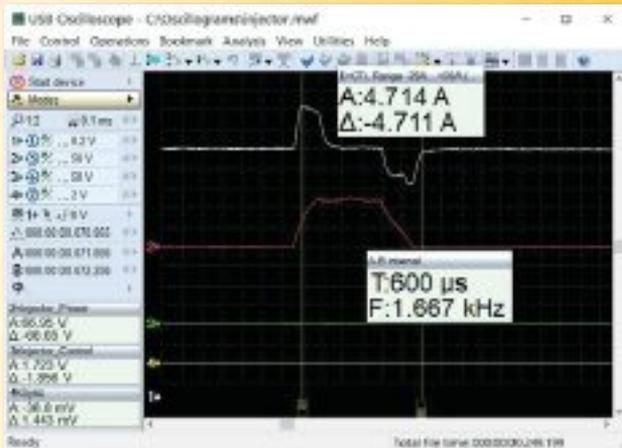
Figure 2: Zoomed injector waveforms on problem vehicle.

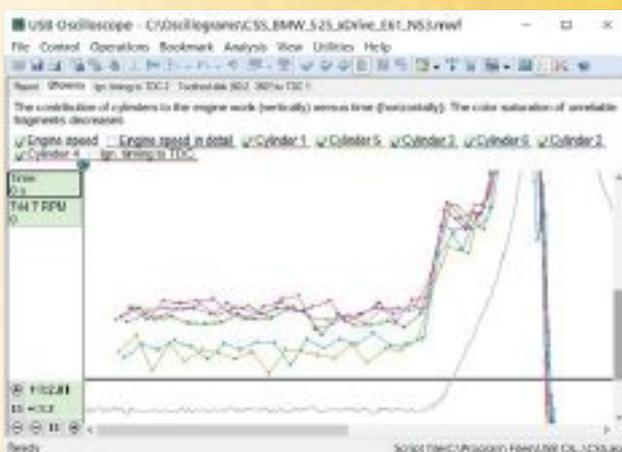
Figure 3: CSS efficiency graphs with the engine cold.

Efficiency graphs on a cold engine showed that cylinders #5 and #6 (graphs of yellow and blue) were less efficient as shown in **Figure 3** on page 14.

By using the Efficiency graphs from my scope's CSS script, along with the fuel trim values shown on the scanner, it was concluded that the injectors on cylinders #1, 2, 3 and 4 delivered excessive amounts of fuel when cold. As the injectors warmed up, close to normal operation was restored. Replacing the injectors restored normal engine operation.

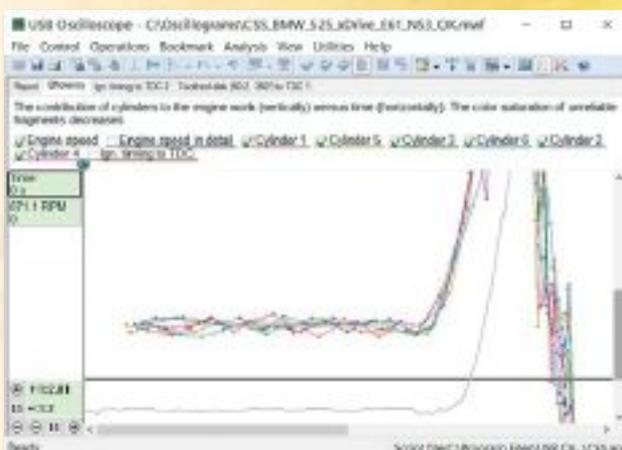
Figure 4: CSS script graph from the problem vehicle with warm engine.

As can be seen in **Figure 4** on page 14, with the engine warmed up, the cylinder efficiencies are much more uniform. Scan tool data also showed that the fuel trim values adjusted to close to zero on both banks.

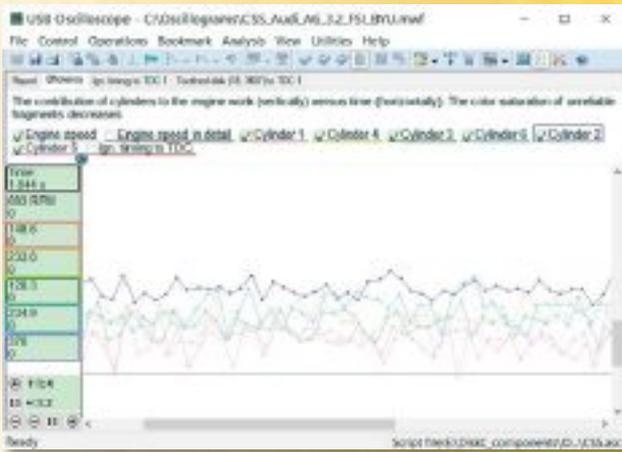
Figure 7: The Efficiency tab of the CSS script.

Figure 7 on page 16 shows that the Efficiency tab of the CSS script has cylinder #2, bank 1 as most efficient and that cylinder #5, bank 2 as the least efficient.

Seeing such a large variation of the cylinders' efficiency with a strong enrichment of the air/fuel mixture, the suspicion was leaking fuel injectors. To test this assumption without removing the injectors, a gas analyzer was used.

The engine was warmed up and shut down. One spark plug at a time was removed and the probe from a gas analyzer inserted in the spark plug hole to measure the HC content directly in the cylinders. In cylinder #5, HC content did not exceed 200 ppm, but in cylinder #2, the analyzer was over-ranging at more than 9,000 ppm. In the other cylinders the HC level was between 3,000 and 7,000 ppm. It was obvious that the injectors were leaking in all the cylinders except #5, with #2 being the worst. Cylinder #5 would misfire because the PCM would attempt to lean out the mixture with the result that #5 became too lean to sustain proper combustion.

The injectors were removed from the engine and installed on a test bench. Once the fuel pressure approached 3.0 Bar (44 psi) the injectors would start leaking. When new injectors were installed on the engine, the fuel trims remained within a range of  $\pm 4\%$ .

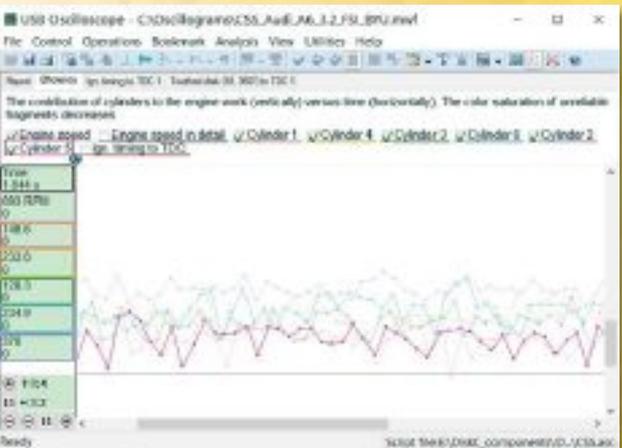
Figure 8: The CSS shows that cylinder #5 is occasionally misfiring.

Figure 8 on page 16 also shows that cylinder #5 is occasionally misfiring.

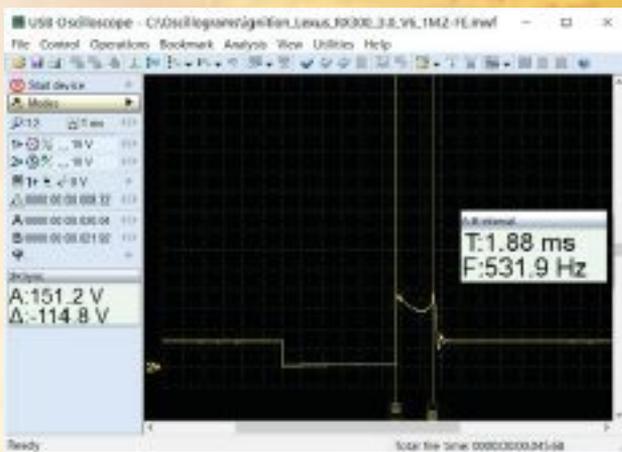
Figure 9: Ignition system problem common to cylinder #2, 4 and 6.

Cylinder bank 1 contains cylinders #1, 3 and 5; bank 2 contains cylinders #2, 4 and 6. During testing it became clear that the misfires occurred intermittently. The engine would run smoothly for a period, then misfire. When the engine was running rough, the misfires occurred on the cylinders in bank 2, as evidenced by the DTCs. Checking of the ignition system showed problems in the secondary or high-voltage circuit of the ignition system for cylinders #2, 4 and 6. An example of the problem is shown in **Figure 9** on page 18.

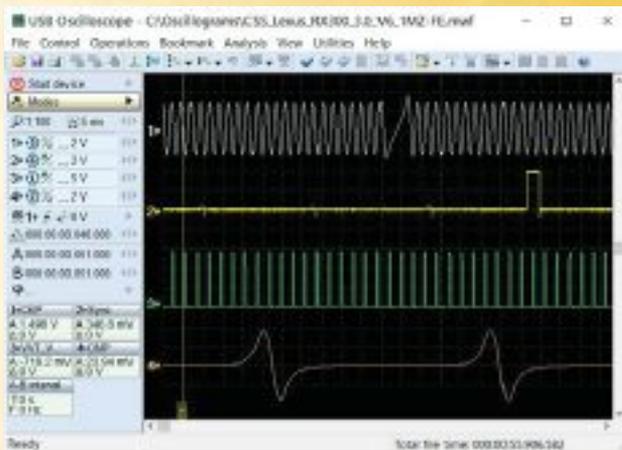
Figure 10: Waveforms recorded to perform valve timing tests.

The Phase tab of the CSS script, among other things, can display the interaction of camshaft timing relative to the crankshaft position sensor signal. Four waveforms were recorded to perform this test. The waveforms are shown in **Figure 10** on page 18.

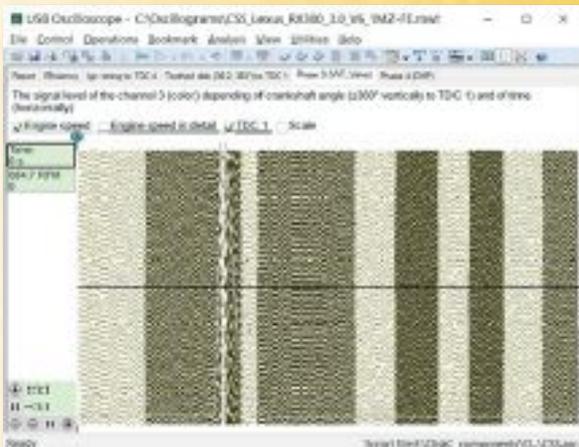
Figure 11: Raster representation of the signals from Figure 10.

After executing the script, we see how the CMP signal moves in relation to the CKP, and how the control signal applied to the VVT system changes. **Figure 11** on page 18 shows this data in a raster or "waterfall"

form. It is seen that the VVT control changed, but the CMP position relative to the CKP did not change.

The test was performed several times to prove out that the problem was, in fact, intermittent. In each case, the electrical signal was as expected, so the final diagnosis was that the problem is mechanical or hydraulic. The VVT actuator was replaced and the problem did not return.

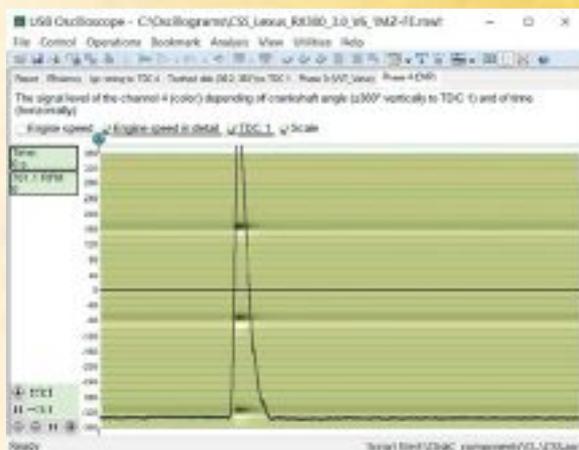
Figure 12: CKP/CMP relationship versus engine speed.

**Figure 12** on page 18 shows the CMP/CKP relationship versus engine speed. The problem is intermittent.
