The Right Diagnostic Tools Can Save You From Extensive — and Expensive — Disassembly Time

**Andrew Shulgin,
Vasyl Postolovskyi and
Olle Gladso**

Contributing Writers and Instructors at Riverland
Technical and Community College in Albert Lea, MN

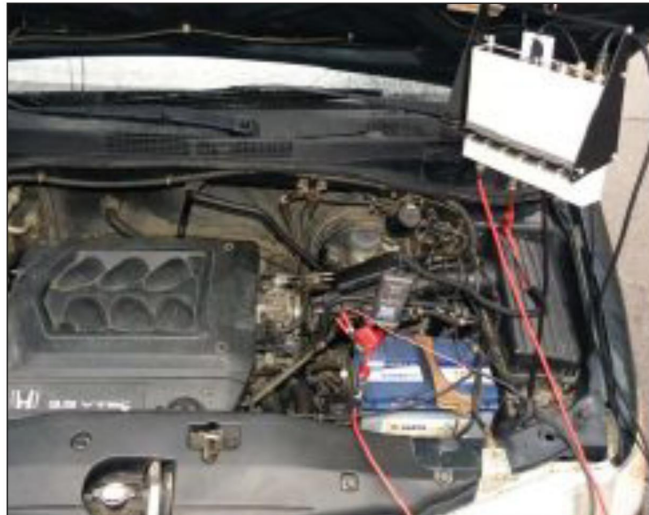
Figure 2: Connecting the USB Autoscope to the vehicle's battery to obtain voltage current waveforms.

The measurement procedure is as follows: Connect the USB Autoscope to the battery as shown in **Figure 2** in order to obtain the battery voltage and current waveform. Start the waveform recording and then start the engine.

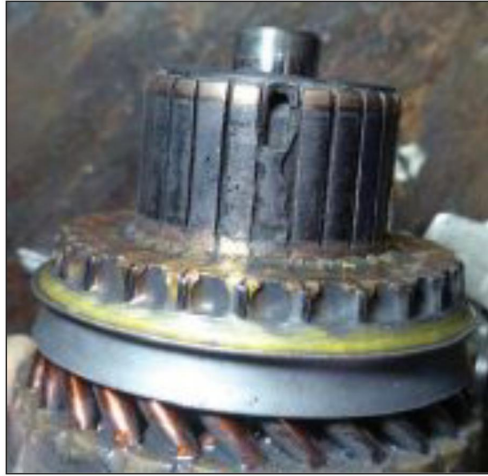
Figure 8: Badly burned commutator segments on a starter armature.

starter components revealed the damage (**Figure 8** on page 12).

The increased switching time of the solenoid, measured at 67 ms, was also caused by the burned commutator segments. Once the starter was repaired, all the measured parameters returned to normal.
