## Using the CSS Script for Unconventional Diagnostic Methods

*Have you ever wondered why engine control systems from different manufacturers have common principles and similar designs, but are diagnosed using differing devices? Could one single tool diagnose engine faults in vehicles coming from different manufacturers? This article will investigate the possibilities.*

# MAXIMIZING TOOLS

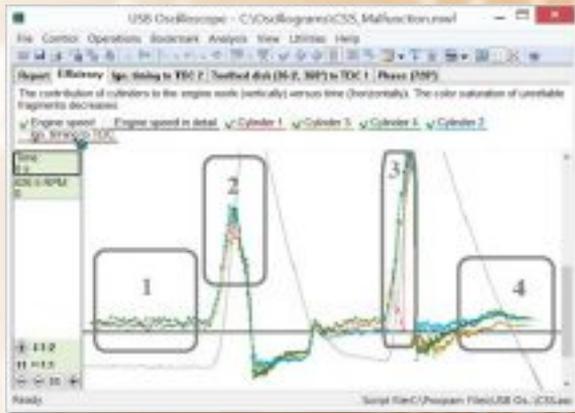
Figure 1: Data shown on the Efficiency tab.

## Figure 1 shows an example of how the data is displayed on the Efficiency tab.

The different colors used in the graph allow us to evaluate each of the cylinders. The representation shows four different operating modes:

1. **Idle.** This part allows us to estimate the quality and stability of the engine at idle.
2. **Relatively slow throttle opening and closing.** This part shows the quality of the air/fuel mixture. Plugged fuel injectors and/or vacuum leaks would show here.
3. **Snap throttle opening.** This mode helps diagnose the quality of the ignition system.

4. **With the ignition shut off and the throttle held at WOT (wide open throttle), the engine is decelerating with no combustion.** This mode displays dynamic compression. Here, cylinder pressure problems caused by worn piston rings, valve timing problems or other issues can be diagnosed. Note that the script is able to analyze engines equipped with ETC (electronic throttle control) even if the default throttle opening is low.

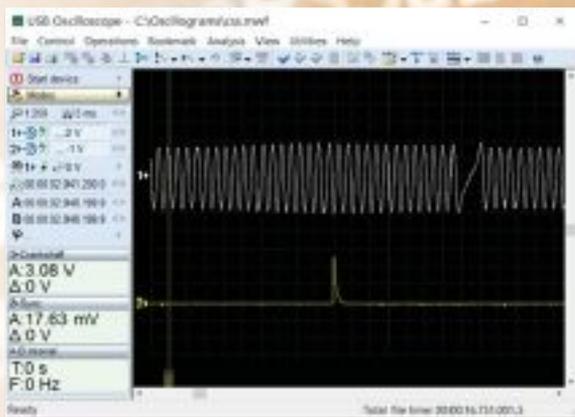
Figure 2: CKP and ignition signal as shown on an oscilloscope screen.

To obtain enough data to run the CSS script, only two connections need to be made:

1. **CKP (crankshaft position) sensor, for obtaining angular velocity (rotational speed), and**
2. **Ignition event in one of the cylinders, for synchronizing.**

## Figure 2 shows these two pieces of data on the oscilloscope screen.

The angular velocity signal is easiest to record from the engine's CKP sensor.

The synchronization or timing signal is easiest to obtain from an ignition coil or plug wire using a synch probe with no direct electrical connection. If a diesel engine, the signal can easily be obtained from one of the fuel injectors either through a mechanical or an electrical connection. Different methods may be required to obtain these signals, depending on the design of the engine and its control unit. It should be noted that these signals can be obtained from almost any engine, regardless of the brand, model and year.

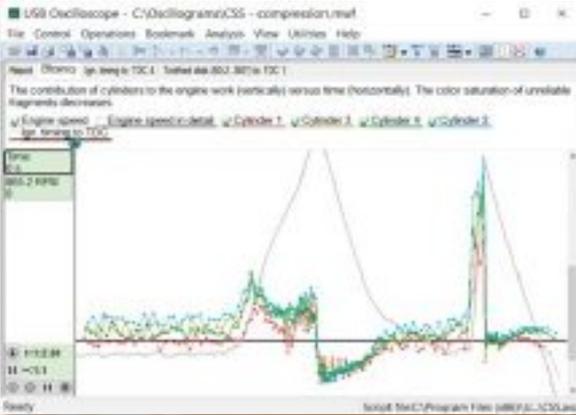
## Figure 3 on page 10 shows the Efficiency data obtained from this vehicle.

It can clearly be seen that the red graph showing the operation of cylinder 1 displays lowered efficiency compared to the graph of the other cylinders during the analyzed engine operating modes, namely:

1. **Idle;**
2. **Smooth throttle opening;**
3. **Snap throttle opening; and**
4. **Deceleration of the engine with no combustion and WOT.**

During analysis of the Efficiency graphs it is usually best to start with the last operation mode of the engine, as it allows you to compare the dynamic compression in the cylinders. At the last stage, the ignition system and the fuel supply are off while the engine is still coasting with the throttle valve kept fully open. Under this condition, the cylinders contain only air that is subsequently compressed as the piston moves up in the cylinder due to the inertia in the engine from the flywheel and crankshaft. Once the piston passes TDC (top dead center), the compressed air in

Figure 3: Efficiency tab from a 2014 Chevrolet Aveo.

**The first example is a 2013 Chevrolet Aveo 1.5L.**

The owner of this car with a 4-cylinder gasoline engine was concerned about a loss of engine power and poor idle quality.

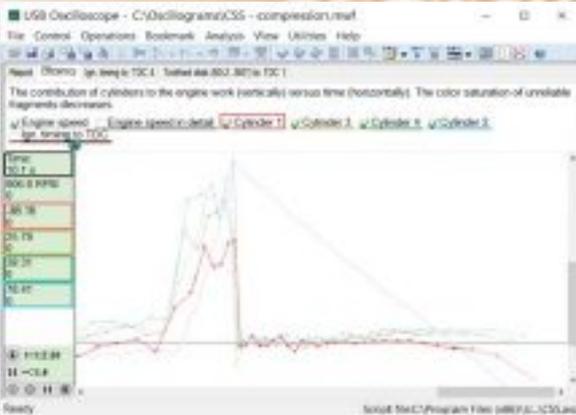
Figure 4: Zoomed latter part of the Efficiency graph.

the cylinder pushes the piston back down. The piston being pushed down causes some acceleration of the crankshaft. More cylinder pressure equates to more acceleration. This crankshaft acceleration is reflected here as the efficiency graphs and thus they show the relative compression of the engine cylinders.

## Figure 4 is the Efficiency graph for cylinder #1 zoomed in on the last phase of the test.

The graph clearly shows that this cylinder, when compared to the other cylinders, provides less crankshaft acceleration. In other words, the cylinder has less output. This lack of output demonstrates compression loss in this particular cylinder. Because the engine speed is decreasing, the amount of time it takes for the compression and power stroke to complete is increasing. This gives the air in the cylinder more time to escape through whatever is causing the compression loss. Since a loss of compression usually causes loss of power and deteriorated idle quality, it was decided to postpone further checking until the engine's mechanical condition had been resolved.

Once the mechanical failure was repaired, the engine operated as designed and further checks were not required.

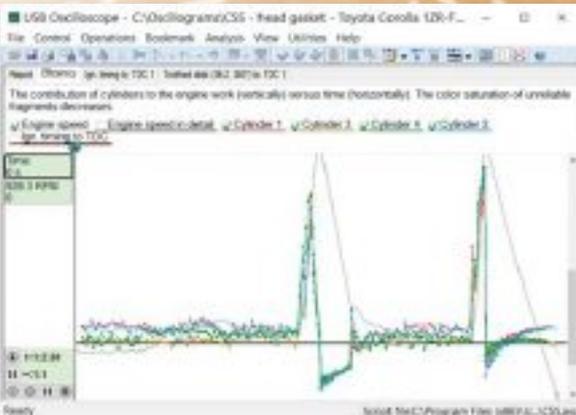
Figure 5: Efficiency graph from a 2007 Toyota Corolla.

## Figure 5 shows the Efficiency graph from a 2007 Toyota Corolla equipped with the 1.6L 1ZR-FE engine.

The yellow and green traces, which correspond to cylinders 3 and 4, have an obvious downward trend in the last phase of the measurement. As previously stated, the last part of the test is performed with ignition and fuel removed (ignition shut off) and throttle held open. The indicated loss of efficiency during this phase is caused by a compression loss.

It is noteworthy that the engine control unit was trying to compensate for the failure by advancing the ignition timing for the weakest cylinder. Due to this compensation, the idle quality was somewhat stable. This is clearly seen on the color traces before the first snap throttle.

During the subsequent repair, it was revealed that the fault occurred due to a blown cylinder head gasket between cylinders 3 and 4, causing low compression in these two cylinders.

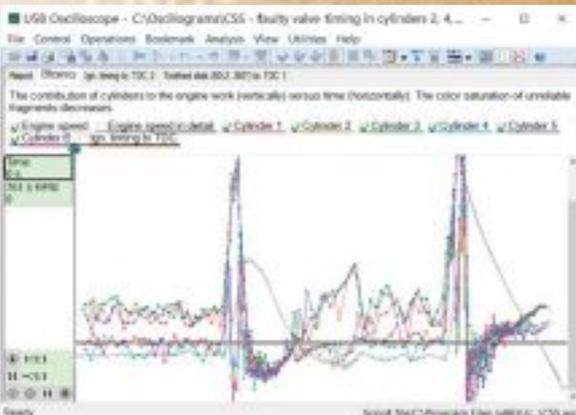
Figure 6: Efficiency graphs from a 2004 Kia Magentis equipped with a 2.5L V6.

## The Efficiency graphs in Figure 6 are from a vehicle that is equipped with a V6 engine.

The graphs shows that under all conditions cylinders 1, 3 and 5 are performing better than cylinders 2, 4 and 6. The last part of the graphs also shows that the dynamic compression in cylinders 1, 3 and 5 is better than in cylinders 2, 4 and 6. This engine has two separate camshafts, one for each cylinder bank. The displayed results are suggestive of a timing problem on the lower performing cylinder bank. The question

is: Is it ignition timing or valve/cam timing that is causing the problem? Ignition timing would not affect dynamic compression, so the most likely problem is cam timing.

Checking of timing marks on the crankshaft and camshaft pulleys confirmed the diagnosis.

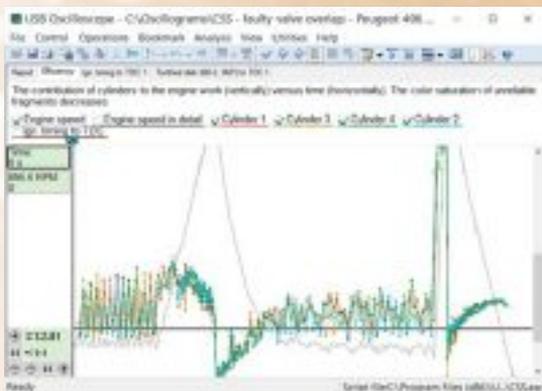
**Figure 7 on page 12 shows Efficiency graphs from a 16-valve engine that has an unstable or rough idle.**

The graphs show that all four cylinders of this engine during idle were intermittently misfiring. During off-idle conditions, the engine was operating smoothly and all four cylinders had equal power contribution and dynamic compression. One common reason for intermittent misfires such as these, which affect all the cylinders, is contamination or dilution of the air/fuel charge in the cylinders. This can be caused by incorrect valve timing causing excessive valve overlap. Since this is a 16-valve engine with two camshafts, one intake and one exhaust, incorrect camshaft timing could be the cause. If the engine is equipped with variable valve timing, problems in that system could have the same effect. The misfire occurs and is intermittent for the following reason: during the valve overlap phase when the engine is at idle, exhaust

gases from the exhaust manifold are drawn into the cylinder on the piston downstroke and may also even flow through the open intake valve into the intake manifold. The mixture in the cylinder will be highly contaminated with exhaust, similar to excessive EGR (exhaust gas recirculation) and the ignition spark is unable to reliably ignite the charge. On the next piston downstroke, exhaust from the exhaust manifold is again drawn back into the cylinder. However, this time the exhaust contains air and fuel and less spent gases since no combustion occurred the previous cycle. The ignition spark is able to ignite the charge or mixture and we have normal combustion. Then the cycle repeats. Exhaust is drawn into the cylinder, misfire occurs ...

Figure 7: Efficiency graphs from a 2001 Peugeot equipped with a 1.8L 16-valve engine.

In this case, the problem was caused by improper installation of the timing belt. Realigning the valve timing solved the problem.

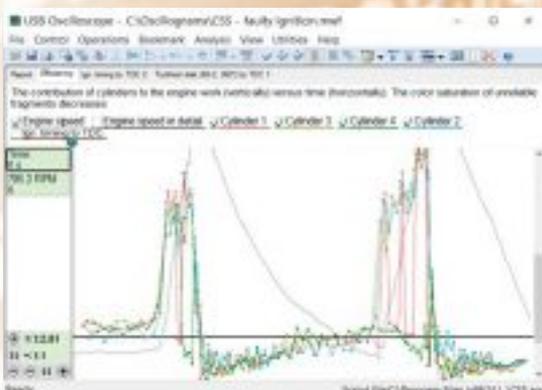
**Figure 8 on page 12 shows Efficiency graphs from an engine that idles smooth, but has a distinct loss of power during acceleration.**

The graphs show that all the cylinders perform equally well during idle conditions, but during smooth and snap throttle, cylinders 1 and 4 (red and green traces) suddenly stopped contributing power

Figure 8: Graphs from a 1998 Volkswagen Passat equipped with a 1.8L turbo engine.

while cylinders 2 and 3 (blue and yellow traces) were unaffected. This particular behavior is typical of an ignition system problem. In general, an ignition system will provide sufficient spark to initiate combustion, or not at all. At idle, there is very little cylinder pressure because the throttle valve is mostly closed and there is very little load on the engine. The voltage requirement to ionize the spark gap in the spark plug is very low and a marginal ignition coil can deliver sufficient voltage to create the spark. However, when the throttle is opened, cylinder pressure increases and along with that the voltage requirement of the ignition system. Now a marginal ignition coil may be unable to deliver sufficient voltage and the ignition spark does not occur. This particular engine is equipped with an ignition system where one ignition coil serves cylinders 1 and 4 and one coil serves cylinders 2 and 3.

Once the ignition coil that served cylinders 1 and 4 was replaced, normal engine operation resumed.

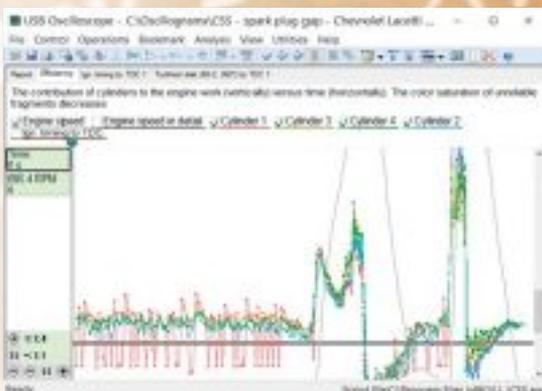
Figure 9: Efficiency graphs from a 2008 Chevrolet Lacetti with a 1.6L engine.

## Figure 9 shows Efficiency graphs from a vehicle with a steady misfire at idle.

The traces show that cylinder 1 (the red trace) has the misfire, but it also shows that the misfire is only partial. In other words, combustion is occurring, but is not complete. This particular graph distortion is characteristic of a too small spark plug gap. Because the gap is so small, the voltage requirement for spark gap ionization is very low. At idle, the requirement is so low there is insufficient spark energy for complete

combustion ionization to occur.

The misfires disappeared once the spark plugs were replaced.

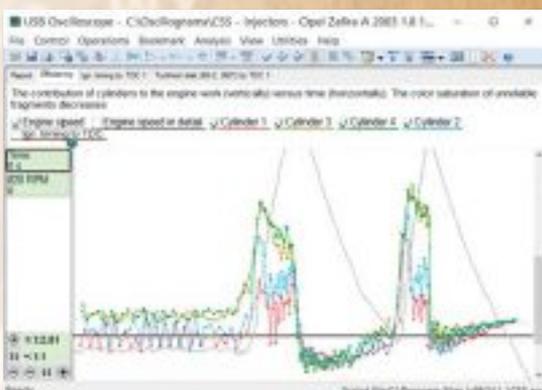
Figure 10: Graphs from a 2003 Opel Zafira equipped with a 1.8L 16-valve engine.

**Figure 10 shows Efficiency graphs from a vehicle with loss of power and misfires.**

The last phase of the graph shows all the cylinders practically superimposed on top of each other. This means that the dynamic compression of all the cylinders is approximately equal. During smooth or slow and snap throttle, cylinders 1 and 2 display less efficiency, and at idle, they were misfiring. This is a typical example of imbalanced fuel injectors. The injectors in cylinder 1 and 2 are injecting less fuel, most likely due to being partially plugged. At idle, the injected amount is very small and the decreased fuel delivery in these two cylinders caused the air/fuel ratio to be too lean for steady combustion. Off-idle, the reduced fuel delivery does not cause a direct misfire in this case, but does cause loss of efficiency.

By cleaning the fuel injectors off the vehicle, the problem was repaired.

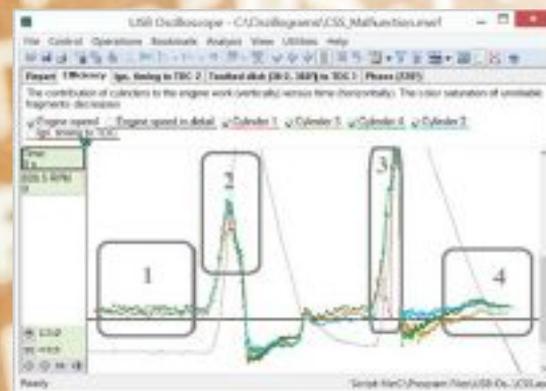
Figure 11: 2005 Chevrolet Lacetti 1.6L 16-valve. First test.

**Figures 11 and 12 are the Efficiency graphs from two tests performed on a vehicle that intermittently would have misfires and loss of power.**

Looking at the graph in Figure 11, it can be seen that in the beginning, cylinder 3 (yellow efficiency graph) did not have any power contribution at all. However, during the smooth throttle valve opening, the cylinder did start to work as it should. Once the cylinder "came online," it remained working. So, we know the faulty cylinder is 3, but we do not know the cause of the fault. For that reason, the test was repeated and the result is shown in Figure 12.

Subsequent disassembling of the engine showed that the cause of failure was that the intake valve of cylinder 3, which was too tight in the guide, would intermittently stick once opened.

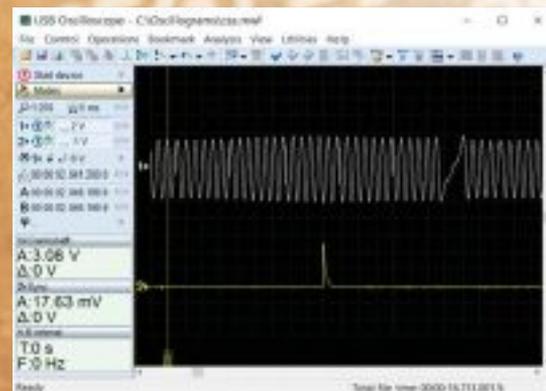
Figure 12: 2005 Chevrolet Lacetti 1.6L 16-valve. Second test.

At the start of the test, all the cylinders are working as designed. However, after the smooth, or slow, throttle opening, cylinder 3 again stopped contributing power. In the last stage of the measurement, we see that the dynamic compression in the problem cylinder has signifi-

cantly deteriorated. So, we have an intermittent loss of compression in cylinder 3. This is a strong indication of a valve problem, most likely a valve that sticks open.
