Using Software to Aid in Engine Mechanical and Electronic Failure Diagnosis

In this article, we'll show how a modern oscilloscope or engine analyzer along with software can greatly enhance engine mechanical and/or electronic failure diagnosis.

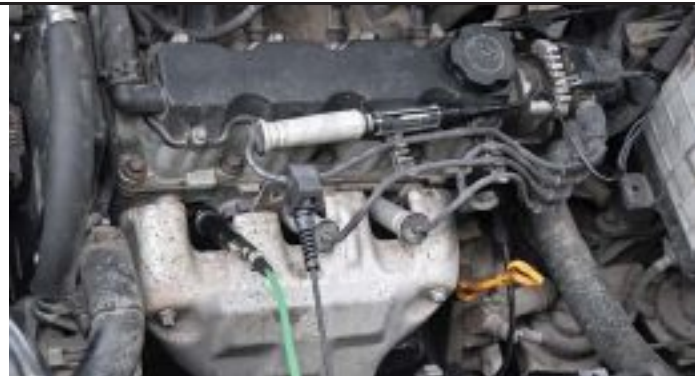
Figure 1: Pressure and synchronization transducer installation.

- To conduct this test it is sufficient to install the pressure transducer in place of the spark plug, then connect a spark tester and synchronization transducer to the high-voltage wire of this cylinder, as shown in **Figure 1**.

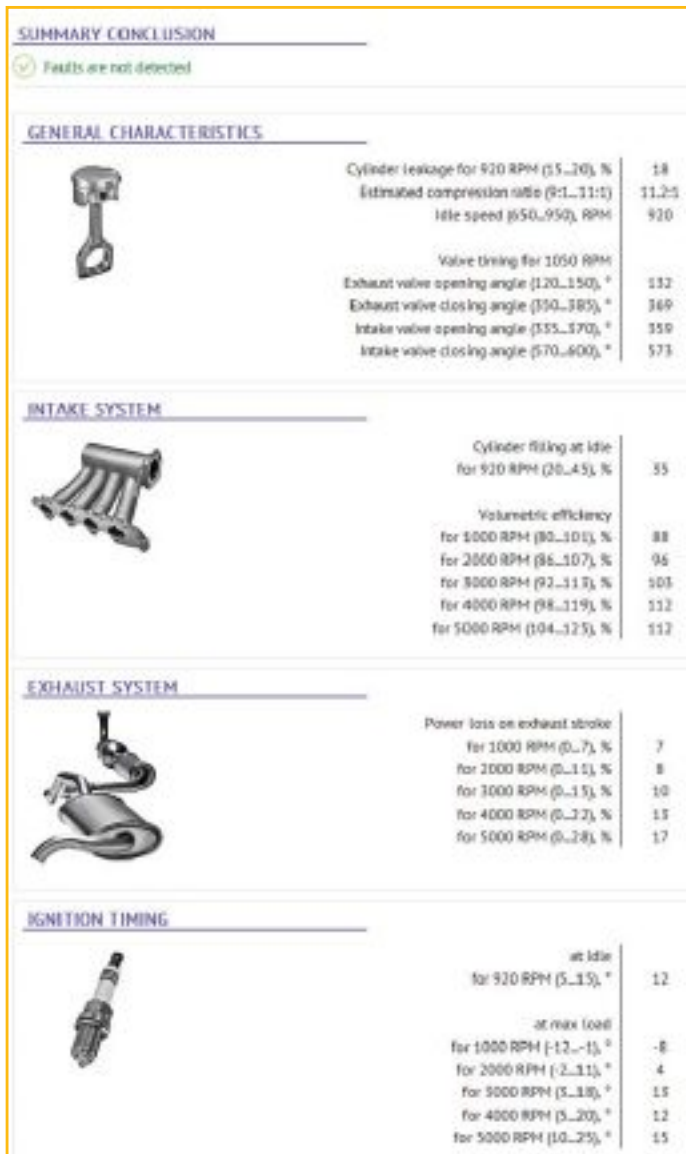
Figure 2: Summary with conclusions from the "Results of analysis" tab.

The Px script produces a report that consists of multiple pages or tabs with the measurement results shown in text, table, graphical and animated forms. In addition, the script analyzes the measurement results and independently identifies diagnosis, which can be found in the "Summary" of the "Results of analysis" tab, see **Figure 2** on page 4. This tab can be printed for inclusion with the customer documents.

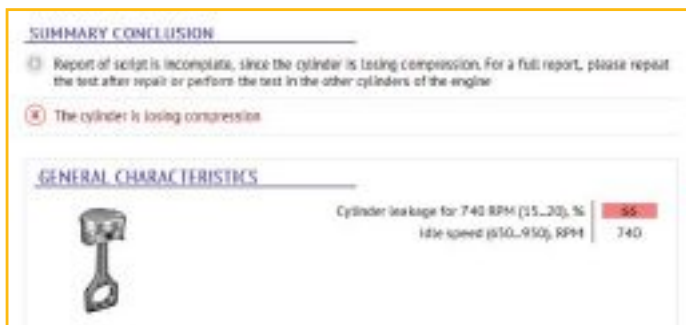
Figure 3: Audi engine with compression loss.

Let's take a look at an example of excessive cylinder leakage on an Audi A6 equipped with a 2.4 V6 engine (AGA). **Figure 3** shows the summary conclusion on an engine with compression loss. Note that the summary is listed as incomplete. The failure is such that a complete engine test cannot be performed until the cause of the failure is repaired.

The amount of gas losses here is 66% and has gone far beyond the typical range of 15-20%. As a result, the script diagnosed "The cylinder is losing compression."

In addition, the script can identify some causes of the leaks. In this case, the reason is the exhaust valve clearance is too small.

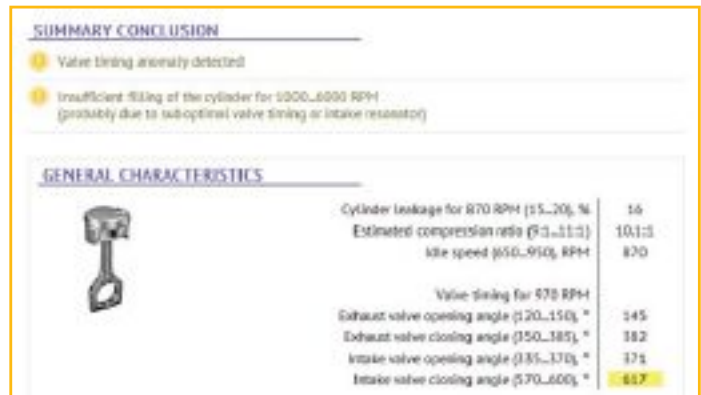
Figure 5: Summary conclusion on an engine with late valve timing.

For the engine diagnosed in **Figure 5**, the script diagnosed "Insufficient filling of the cylinder..." and found the cause of this as "Valve timing anomaly detected" – namely, the measured closing angle of the intake valve has gone beyond the typical range of 570-600°. **Figure 5** is the script's summary conclusion based on the diagram in **Figure 4**.

A diagnosis of late valve timing often points to an incorrect camshaft installation. In this case, the evidence points to an incorrect intake camshaft timing, either a problem from installation or something such as the timing belt or chain slipped. Too late closing of the intake valve results in a substantial part of the air/fuel mixture being pushed back from the cylinder into the intake manifold as the piston starts on the compression stroke. As a result, there is considerably less air and fuel in the cylinder after the closing of the intake valve than it could be. In practical terms, this causes a loss of effective compression ratio. Because of this, the engine power is significantly reduced.

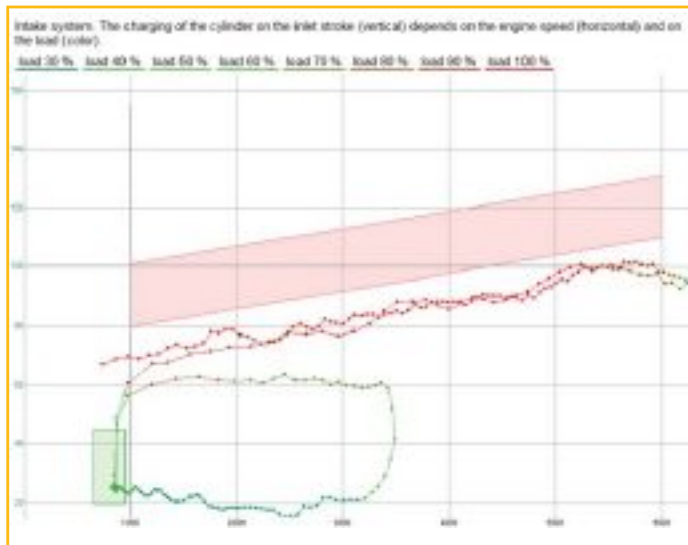
Figure 7: Cylinder filling in graph form.

In the table shown in Figure 6, it's clear that at all engine speeds the measured values of the cylinder filling are below typical range. In Figure 7 it is shown in graph form that the filling diagram in red, corresponding to snap throttle, is located below the limits of the standard areas.

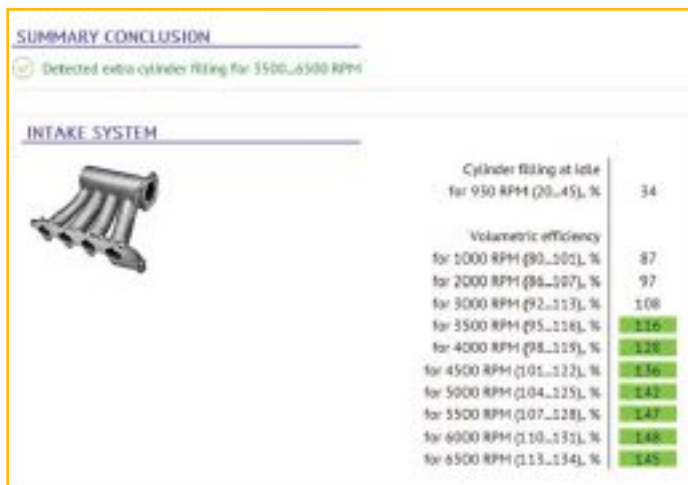
Figure 8: Summary conclusion on volumetric efficiency on a turbocharged engine.

The following is an example of the test results from a turbocharged engine on a Ford Focus. Figure 8 clearly shows a volumetric efficiency above 100% in higher rpm ranges. Figure 9 shows above 100% volumetric efficiency on the same engine as in Figure 8, but in graph form. The results clearly show that the turbo adds significant fill at engine rpms above 3,000, and the extra fill increases drive torque by approximately 20% between 4,000 and 6,000 rpm.

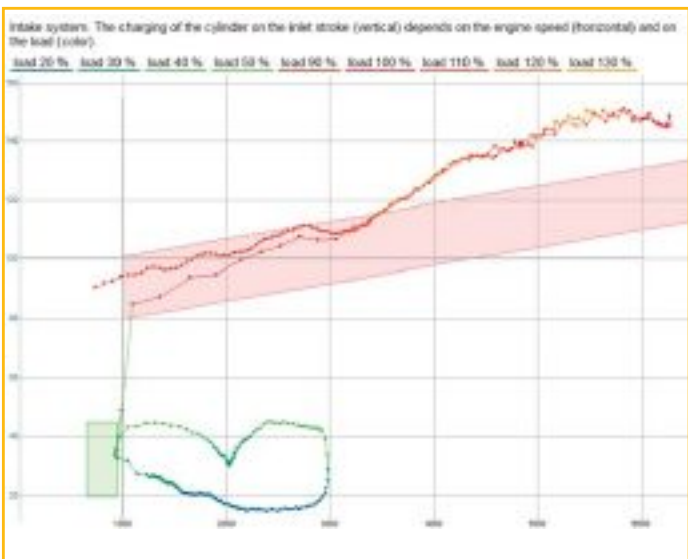
Figure 9: Graph depicting above 100% volumetric efficiency due to use of a turbocharger.

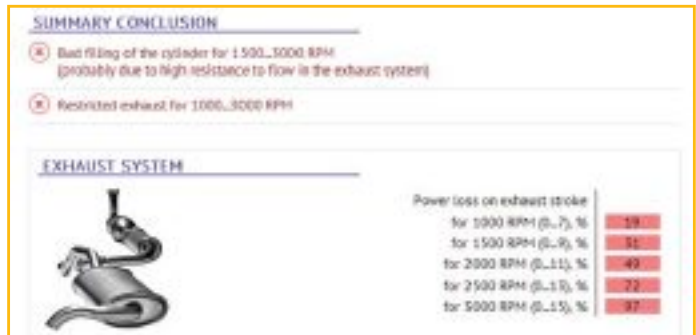
Figure 10: Severe exhaust system restriction.

The script is testing one more important engine system – the exhaust and potential exhaust system restriction(s). Figure 10 is an example from a vehicle where the exhaust system is restricted, causing power loss.

Here, from the script report, it is seen that the blockage of the exhaust system not only led to an increase of power losses on the exhaust stroke, but also negatively affected the filling of the cylinder (volumetric efficiency) with fresh mixture. Due to insufficient cylinder scavenging there is less room for a fresh air/fuel

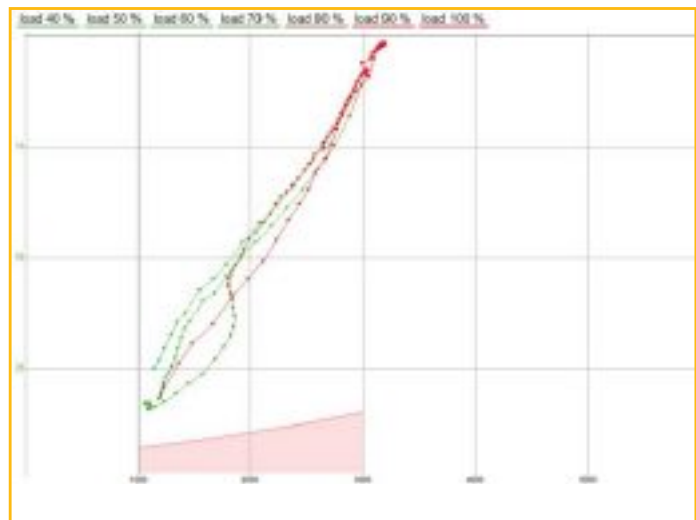
Figure 11: The engine is unable to go above 3,300 rpm, due to severe exhaust system restriction.

mixture on the intake stroke. The cylinder is completely filled, but the density of the charge is reduced (inert gas takes up room, allowing less air and fuel to enter). Loss of fill density in turn reduces the power of the given cylinder. The result is that at engine speeds just above 3,300 rpm, all the power developed by the engine cylinder is spent on cleaning the cylinder from the exhaust gases on the exhaust stroke and the engine speed cannot be increased more. **Figure 11** shows this clearly.

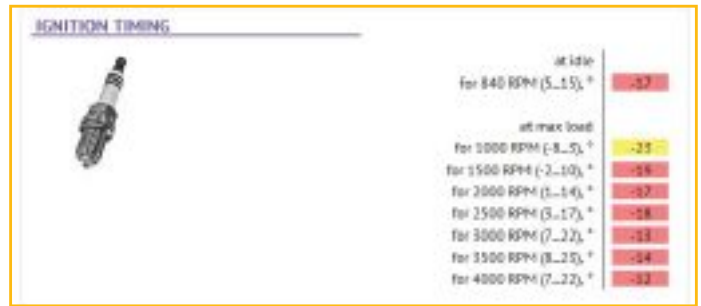
Figure 12: Summary conclusion showing late ignition timing at various rpm ranges.

Figures 12 and 13 show an example of late ignition timing. This example shows incorrect initial ignition advance angle. Ignition timing is not adjustable on this particular engine because it does not have an adjustable distributor. Diagnosis and tear down found the reluctor wheel for the crankshaft position sensor incorrectly installed. **TS**

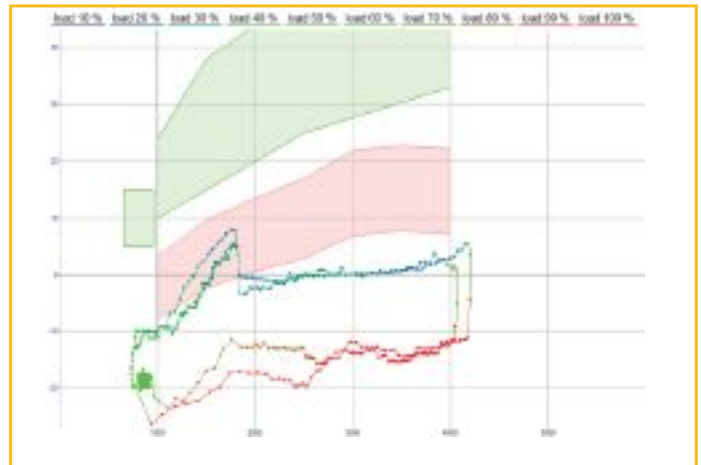
Figure 13: Graph showing late ignition timing.
