## Simple Answers to Difficult Questions: Troubleshooting Complex Systems

### BMW 525

## Audi A6

## Lexus RX 300

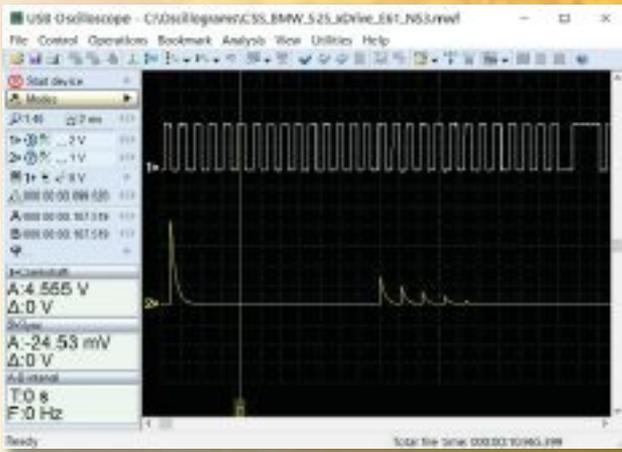
Figure 5: Secondary ignition synch signal.

Note that to run the CSS script with cylinder identification, a synch signal is necessary. This engine implements multistrike ignition where the mixture is ignited by a single spark and an additional spark is generated approximately in the middle of the stroke. For this reason, a primary ignition signal could not be used for synchronization. However, a secondary ignition signal can be used, because the amplitude of the subsequent strikes are much lower than the amplitude of the initial strike. **Figure 5** shows the synch signal obtained from the secondary side of the ignition coil using a normal plug wire as an extension. (This engine uses COP.)

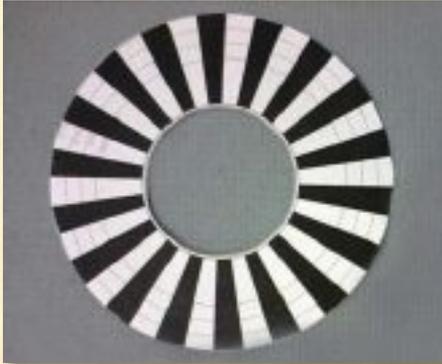
Figure 6: Disc used with an optical sensor to generate engine speed signal.

A way to measure crankshaft angular velocity is necessary for the CSS script to operate properly. However, it was difficult to gain access to the signal from the CKP sensor due to the way the sensor and the connector at the PCM is designed. The USB Auto-scope provides for the use of an external optical laser as an engine speed sensor. It is necessary to create some way for the laser sensor to read the crankshaft velocity. One way that works well is to attach a printed marker disc. This disc can be easily made using a printer; an example of a disc is shown in Figure 6 on page 16.
